Asbestos Demolition Survey

J000766
Issue: 1
Surveyor: Paul Greenan

Buncrana Leisure Centre, Co Donegal

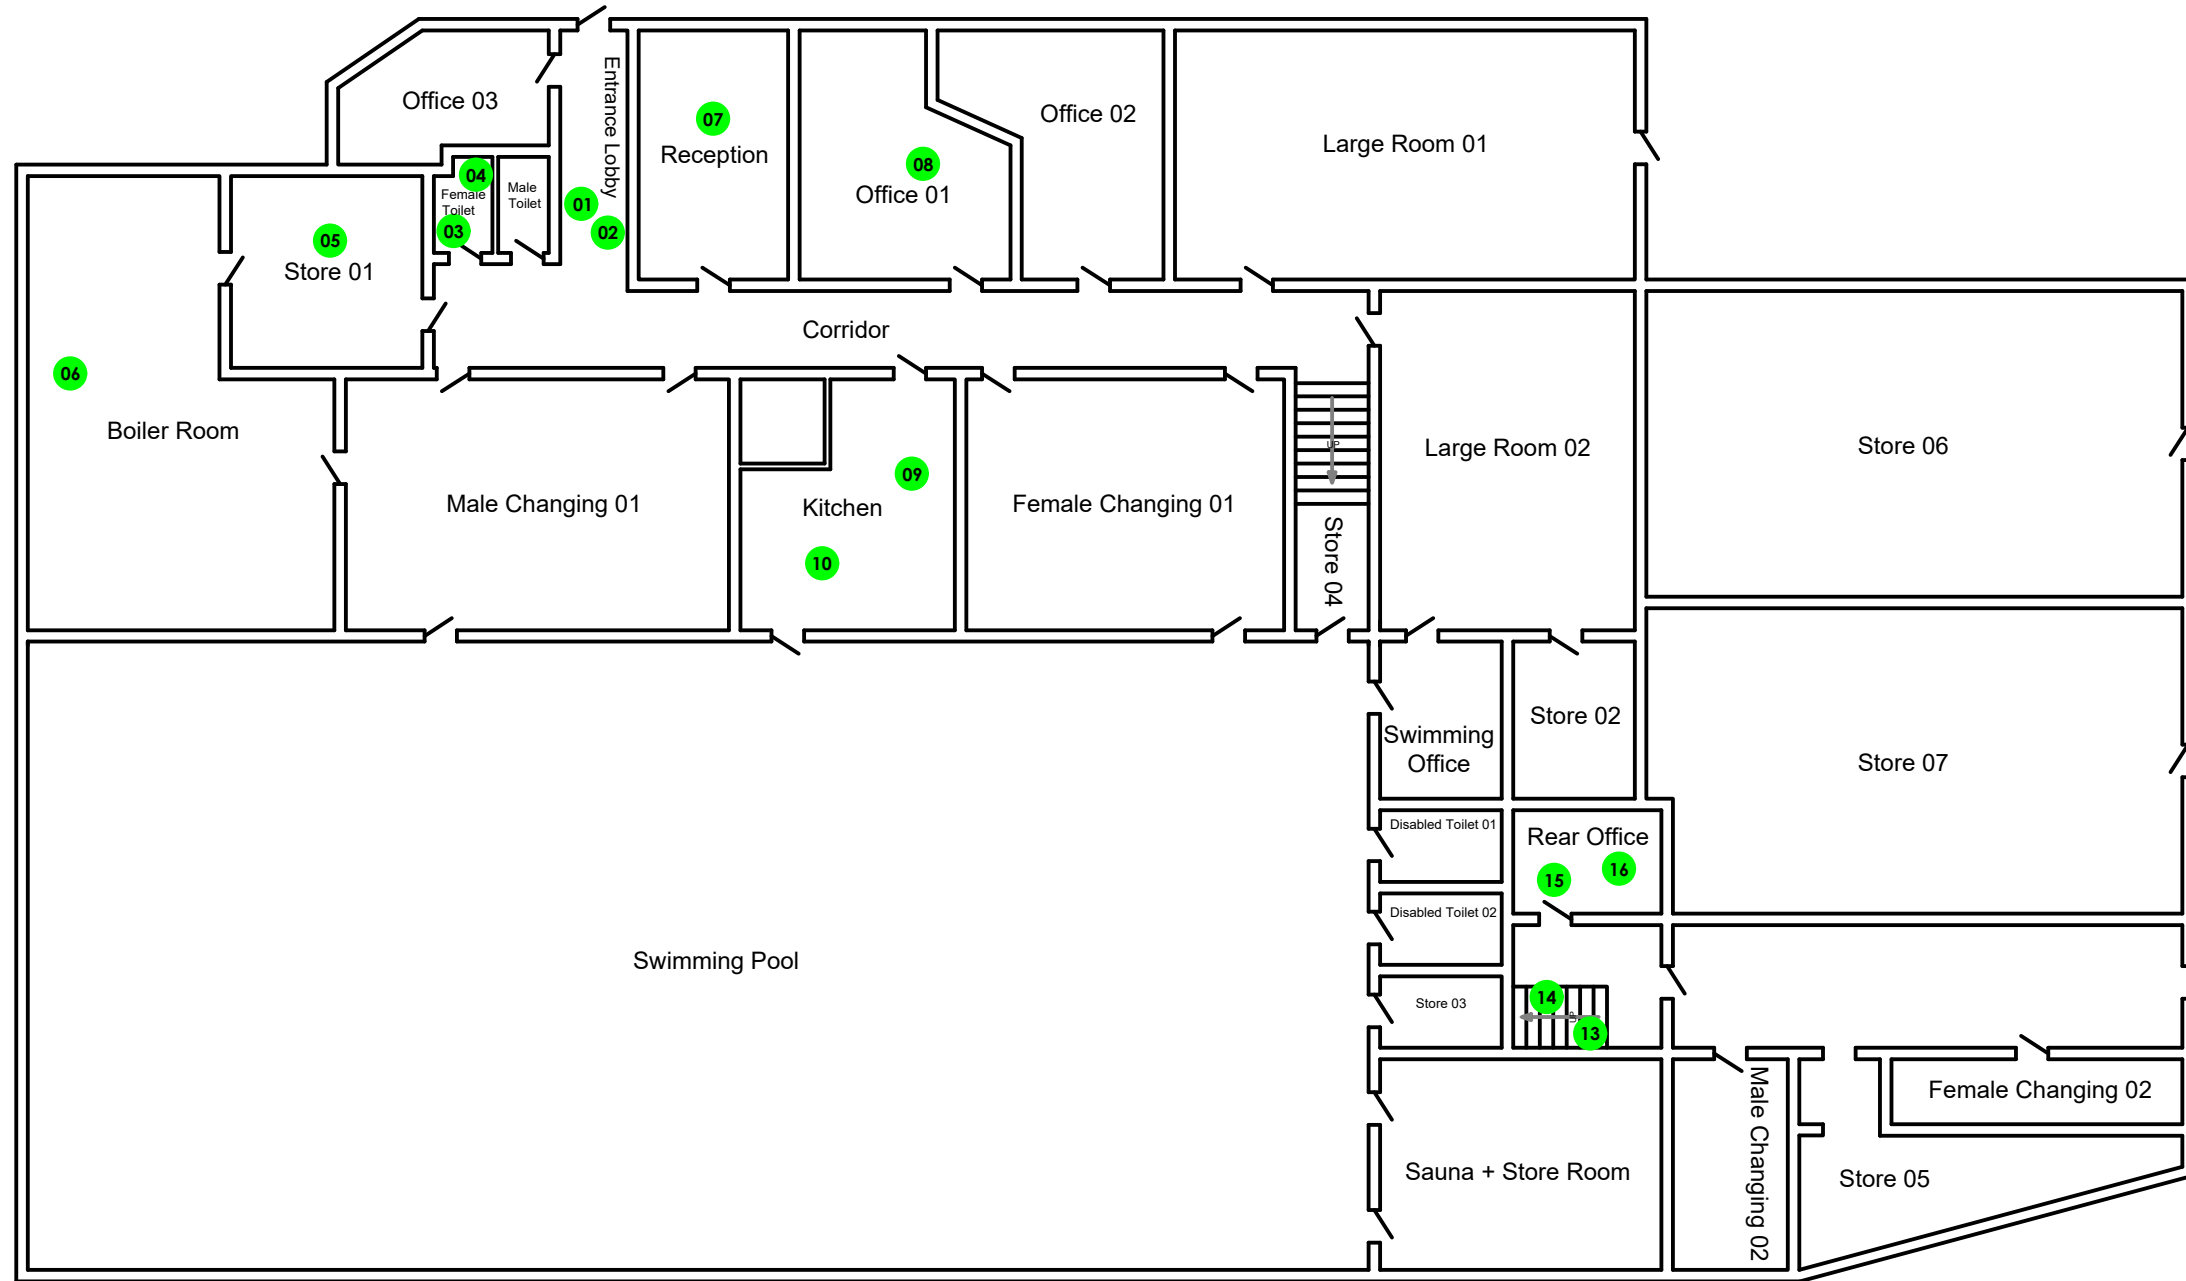
Last added: J000766 - 9496/23	Drawn By: LP	Checked By: GK	Date: 07/06/2023
Title: Demolition Survey of Buncrana Leisure Centre Ardaravan Donegal Ground Floor			
Asbestos Key Plan			
Drawing Number: 9496/23/001	Scale: NTS@A3

- Item No. 1 - CF000805 - Entrance Lobby - Cream vinyl floor tiles
No asbestos detected
- Item No. 2 - CF000806 - Entrance Lobby - Orange vinyl floor tiles
No asbestos detected

- Item No. 3 - as per CF000805 - Ladies Toilet - Cream vinyl floor tiles
No asbestos detected
- Item No. 4 - CF000807 - Ladies Toilet - Brown vinyl floor tiles
No asbestos detected

- Item No. 5 - as per CF000805 - Store 01 - Cream vinyl floor tiles
No asbestos detected
- Item No. 6 - as per CF000805 - Boiler Room - Cream vinyl floor tiles
No asbestos detected

- Item No. 7 - as per CF000805 - Reception - Cream vinyl floor tiles
No asbestos detected
- Item No. 8 - as per CF000805 - Office 01 - Cream vinyl floor tiles
No asbestos detected

- Item No. 9 - as per CF000805 - Kitchen - Cream vinyl floor tiles
No asbestos detected
- Item No. 10 - as per CF000806 - Kitchen - Orange vinyl floor tiles
No asbestos detected

- Item No. 13 - as per CF000805 - Rear Stairs - Cream vinyl floor tiles
No asbestos detected
- Item No. 14 - as per CF000806 - Rear Stairs - Orange vinyl floor tiles
No asbestos detected

- Item No. 15 - as per CF000805 - Rear Office - Cream vinyl floor tiles
No asbestos detected
- Item No. 16 - as per CF000806 - Rear Office - Orange vinyl floor tiles
No asbestos detected

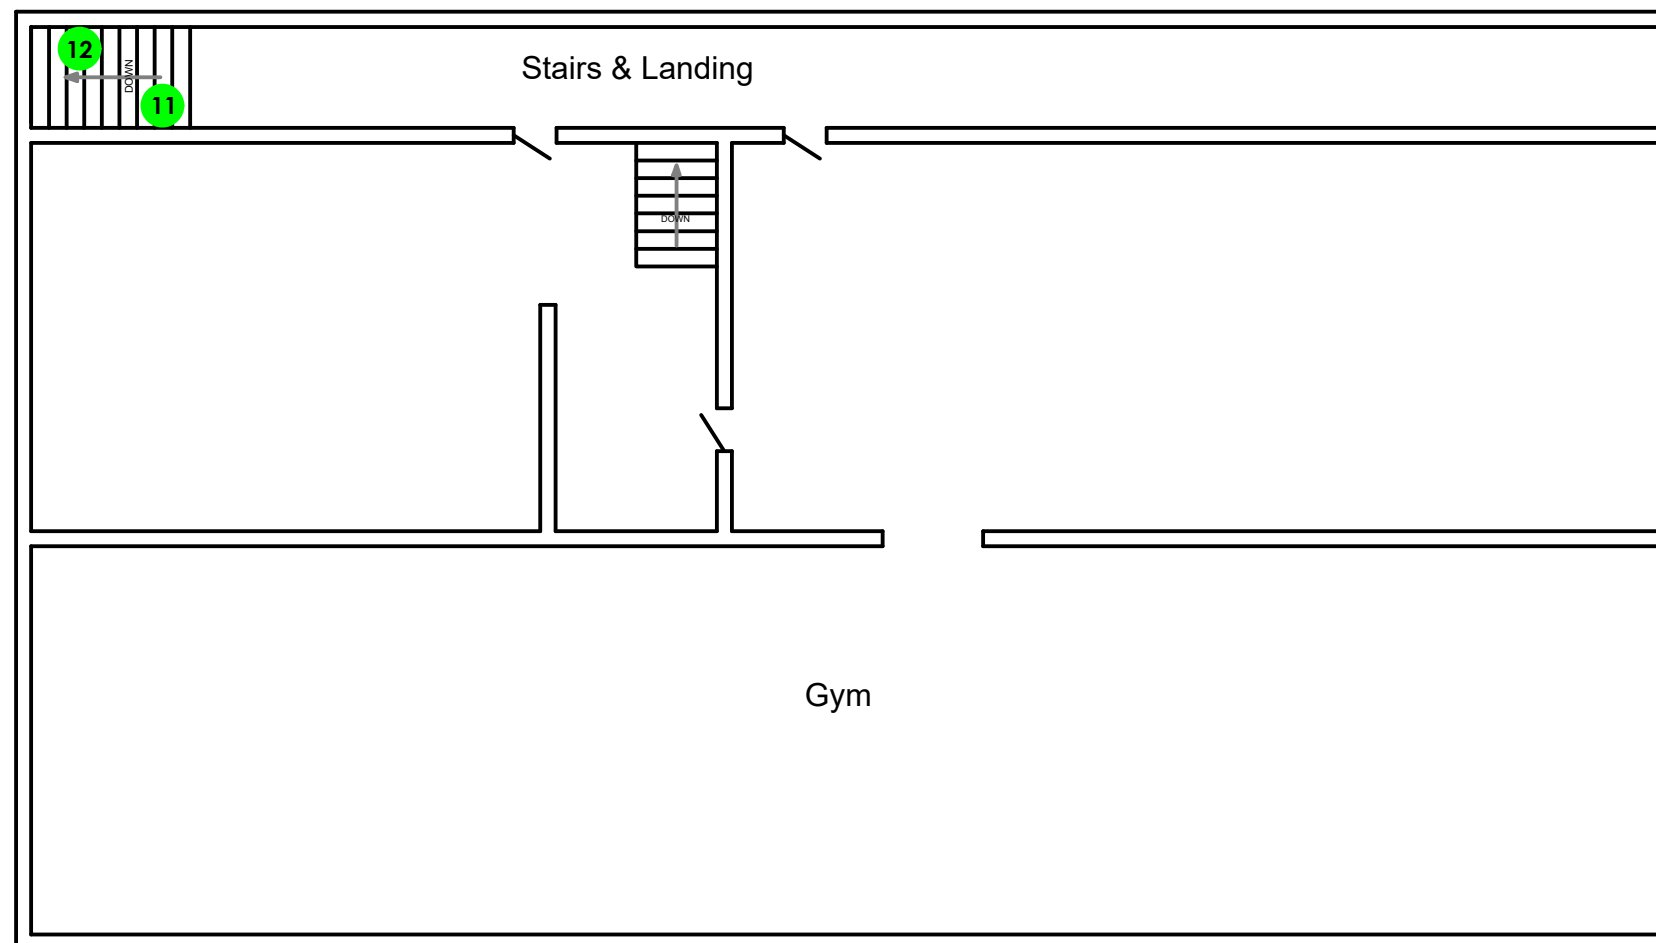
Last added: J000766 - 9496/23	Drawn By: LP	Checked By: GK	Date: 07/06/2023
Title:			Demolition Survey of Buncrana Leisure Centre Ardaravan Donegal First Floor
Drawing Number:			9496/23/002
Scale:			NTS@A3
Asbestos Key Plan

Item No. 11 - as per CF000805 - Stairs and Landing - Cream vinyl floor tiles
No asbestos detected

Item No. 12 - as per CF000806 - Stairs and Landing - Orange vinyl floor tiles
No asbestos detected

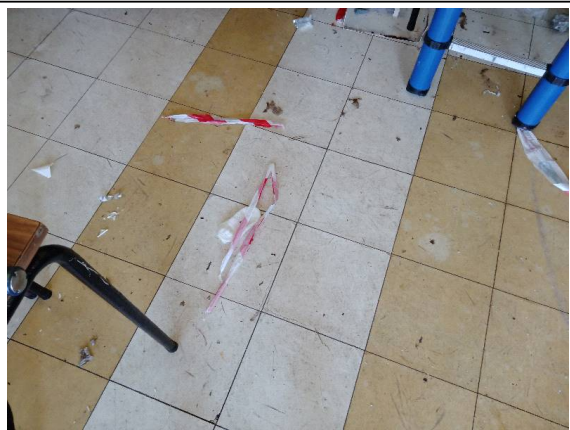
Item ID	CF000805
	Sample Location	Entrance Lobby
	Component	Cream vinyl floor tiles
	Level of Identification	Sample
	Composition	NADIS

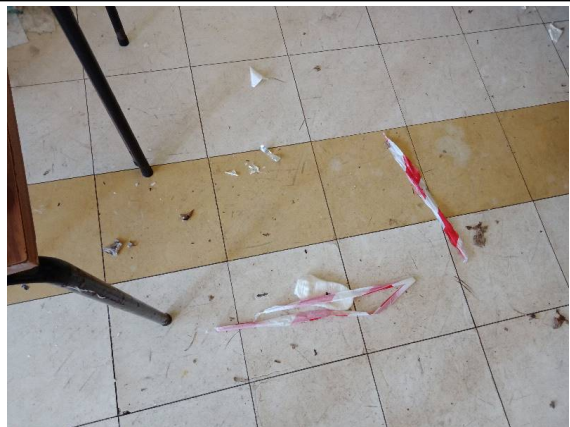
Item ID	CF000806
	Sample Location	Entrance Lobby
	Component	Orange vinyl floor tiles
	Level of Identification	Sample
	Composition	NADIS

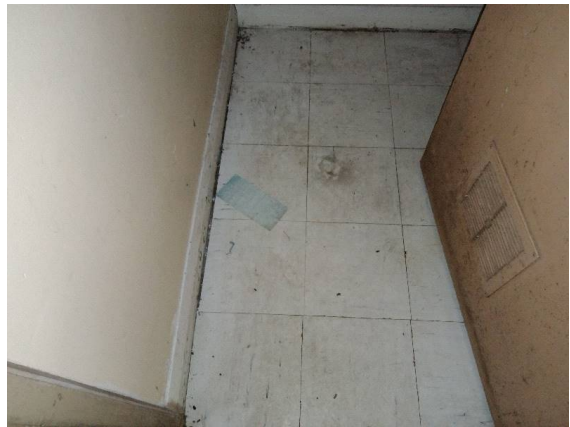
Item ID	CF000805
	Sample Location	Ladies Toilet
	Component	Cream vinyl floor tiles
	Level of Identification	Sample
	Composition	NADIS

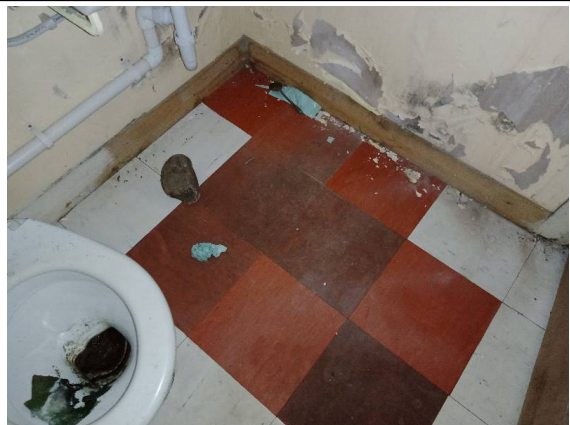
Item ID	CF000807
	Sample Location	Ladies Toilet
	Component	Brown vinyl floor tiles
	Level of Identification	Sample
	Composition	NADIS

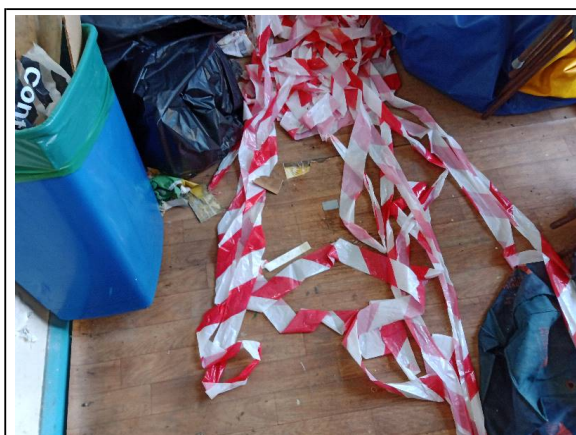
Item ID	CF000805
Sample Location	Store Room 01
Component	Cream vinyl floor tiles
Level of Identification	Sample
Composition	NADIS

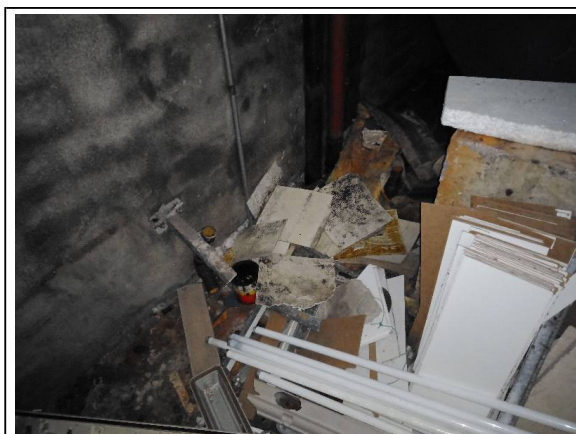
Item ID	CF000805
Sample Location	Boiler Room
Component	Loose cream vinyl floor tiles
Level of Identification	Sample
Composition	NADIS

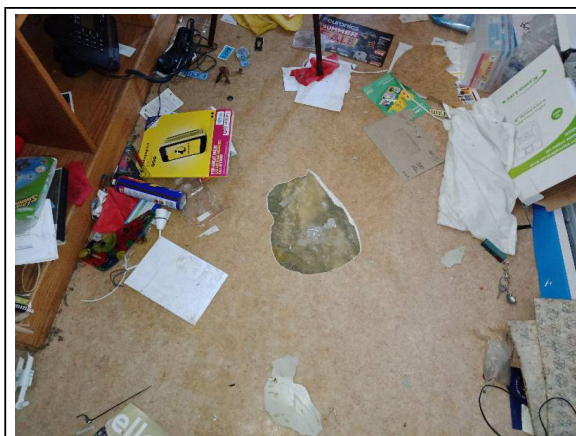
Item ID	CF000805
Sample Location	Reception
Component	Cream vinyl floor tiles
Level of Identification	Sample
Composition	NADIS

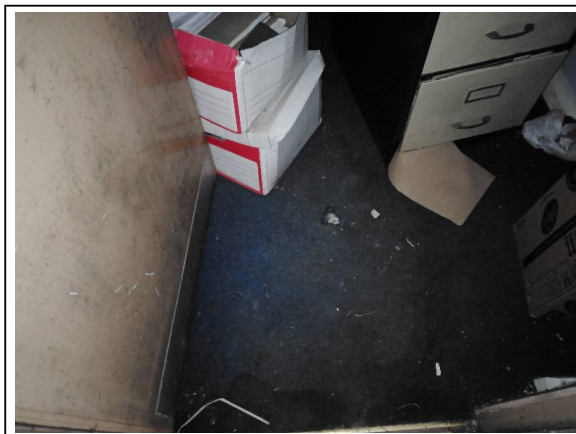
Item ID	CF000805
Sample Location	Office 01
Component	Cream vinyl floor tiles
Level of Identification	Sample
Composition	NADIS

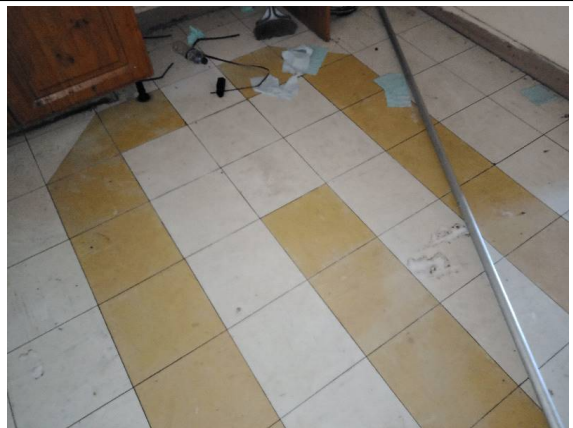
Item ID	CF000805
	Sample Location	Kitchen
	Component	Cream vinyl floor tiles
	Level of Identification	Sample
	Composition	NADIS

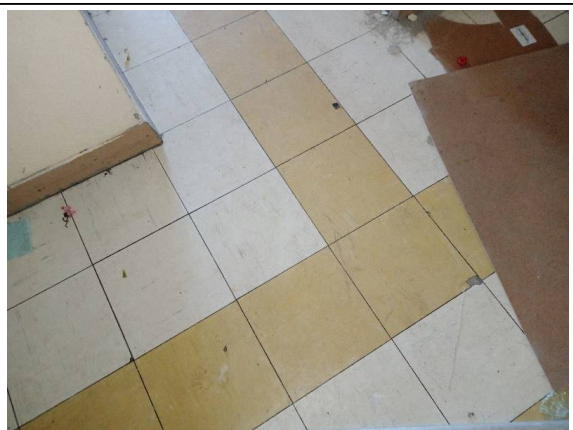
Item ID	CF000806
	Sample Location	Kitchen
	Component	Orange vinyl floor tiles
	Level of Identification	Sample
	Composition	NADIS

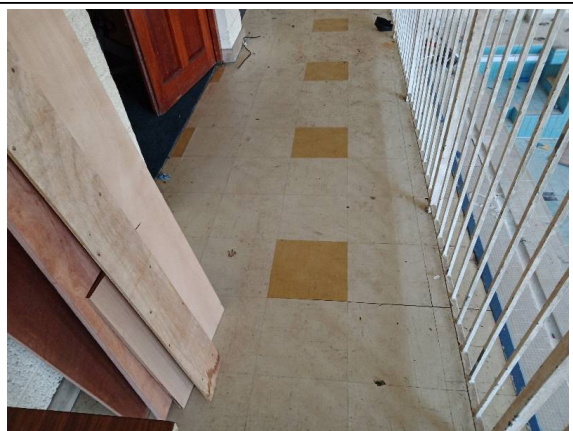
Item ID	CF000805
	Sample Location	Stairs and Landing
	Component	Cream vinyl floor tiles
	Level of Identification	Sample
	Composition	NADIS

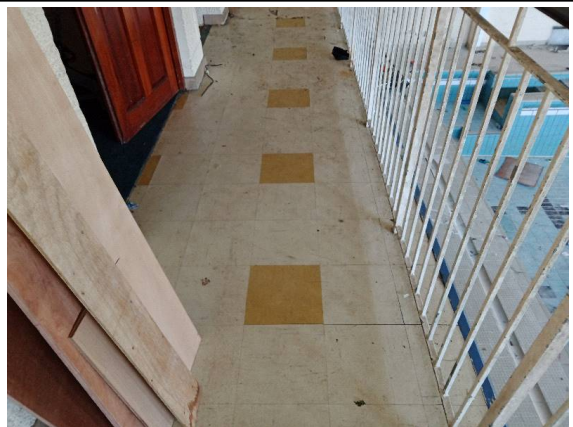
Item ID	CF000806
	Sample Location	Stairs and Landing
	Component	Orange vinyl floor tiles
	Level of Identification	Sample
	Composition	NADIS

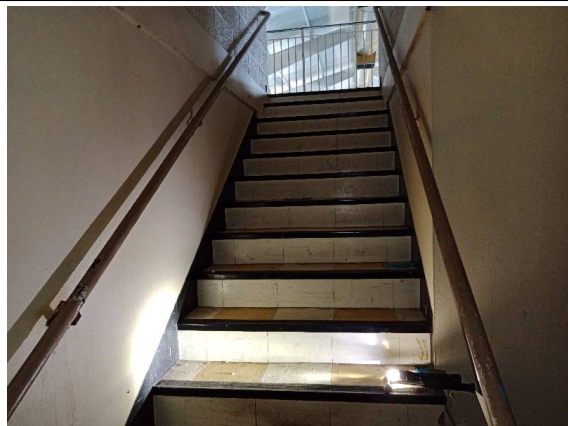
Item ID	CF000805
	Sample Location	Rear Stairwell
	Component	Cream vinyl floor tiles
	Level of Identification	Sample
	Composition	NADIS

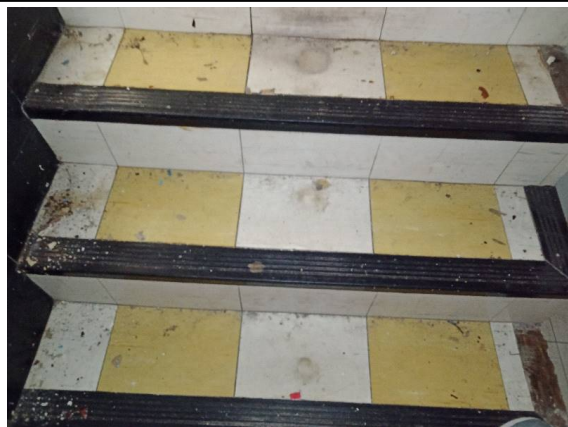
Item ID	CF000806
	Sample Location	Rear Stairwell
	Component	Orange vinyl floor tiles
	Level of Identification	Sample
	Composition	NADIS

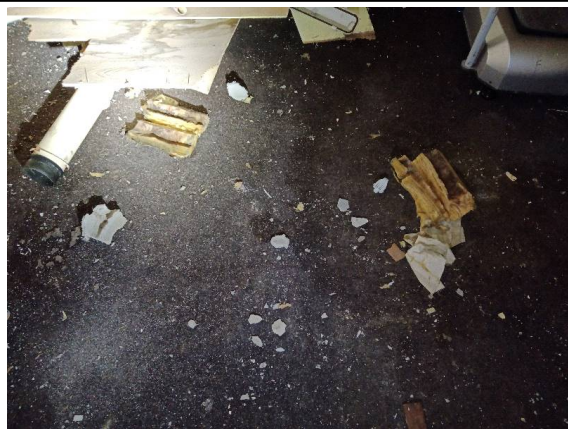
Item ID	CF000805
	Sample Location	Rear Office
	Component	Cream vinyl floor tiles
	Level of Identification	Sample
	Composition	NADIS

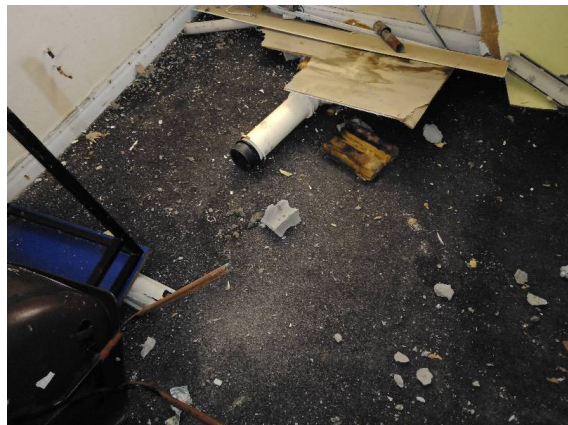
Item ID	CF000806
	Sample Location	Rear Office
	Component	Orange vinyl floor tiles
	Level of Identification	Sample
	Composition	NADIS
