**RESIDENTIAL DEVELOPMENT,  
BALLYHASKEY, NEWTOWNCUNNINGHAM,  
COUNTY DONEGAL**

Road Safety Audit Stage 1

**DONEGAL COUNTY COUNCIL**

FEBRUARY 2025

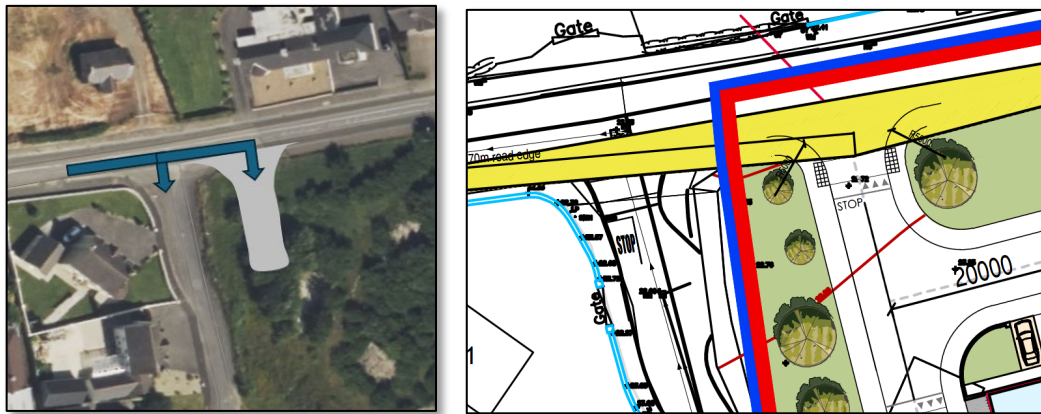
### 2.1 **Problem:** Driver Confusion **Location:** Accessing the Development

The proposed access road is immediately adjacent to the access for Meadowfield Manor. Drivers wishing to access the Ballyhaskey Development may become confused with both entrances being so close to each other. These may contribute to sudden manoeuvres resulting in rear end shunt collisions. In addition, a vehicle stopped waiting to exit one access may obstruct visibility for motorists exiting the adjacent access point. This may contribute to a turning collision at this location.

**Recommendation:** Revise the location of the proposed access as necessary to reduce the risk of driver confusion and restricted visibility splays at the existing and proposed access points.

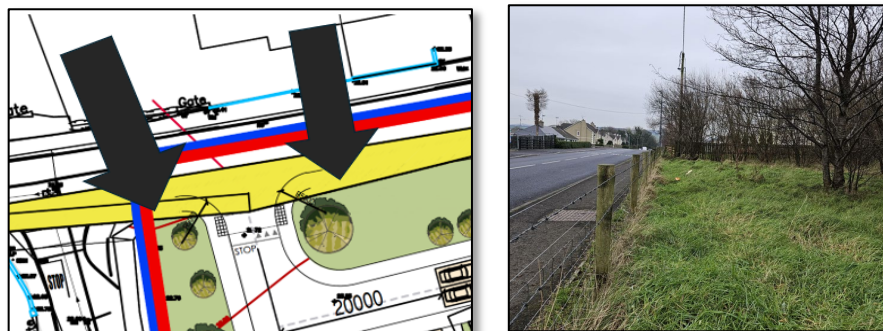
### 2.2 **Problem:** Visibility Splays **Location:** Exiting the Development

Visibility splays are indicated on the exit from the development. The visibility splays are detailed on the drawing crossing a landscaped area where trees, shrubs etc. are proposed. Over time, excessive growth coupled with a lack of ownership/maintenance may result in visibility splays being reduced. This may contribute to collisions when vehicles are exiting the junctions.

**Recommendation:** Ensure that trees & shrubbed areas are not incorporated within the extents of the visibility splays.

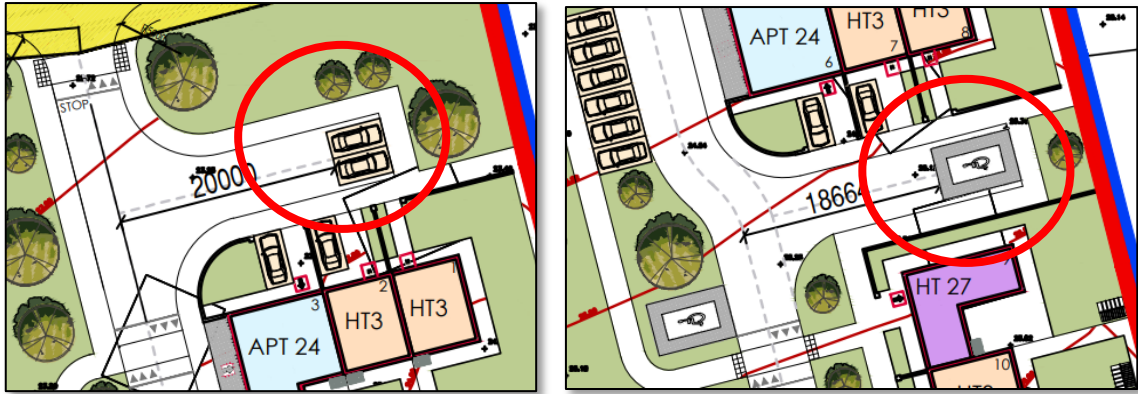
2.3 **Problem:** Reversing from Cul-de-sacs  
**Location:** Adjacent to House No. 1 and 8

The design drawing indicates parking bays at the end of cul-de-sacs adjacent to house No. 1 and 8. The position and layout of these bays may result in a motorist having to reverse into or out of the bay over a substantial distance. Such a manoeuvre may increase collision risk within the proposed development.

**Recommendation:** Ensure that the layout of parking bays does not lead to motorists reversing over long distances when entering or exiting.

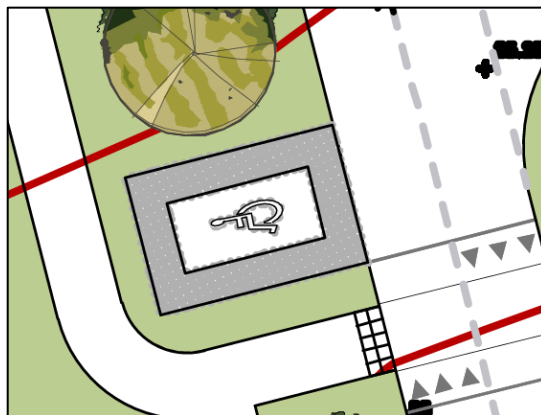
2.4 **Problem:** Disabled Parking Access  
**Location:** Across from No. 9

A disabled car parking space is located at the western side of the access road, however access to the footpath from the bay is across a grassed area. Mobility impaired pedestrians using these car parking spaces will have to travel through the grassed area where they may be a likelihood of slips and fall or across the access road where they will be at an increased risk of being struck by a passing vehicle

**Recommendation:** Ensure disabled motorists can safely access the footpaths from the disabled parking bay.

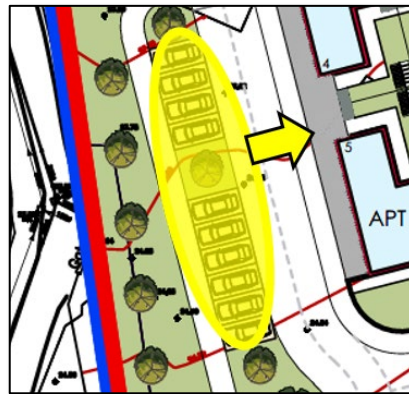
**2.5 Problem:** Pedestrians Crossing at Unsafe Locations**Location:** Western Side of the Access Road

A pedestrian crossing is proposed at house no. 3, however, the location of the crossing does not cater for the desired route of pedestrians who are parking on the western side of the access road. A lack of crossing facilities to cater for pedestrian desire lines may lead to pedestrians crossing at full height kerb/unsafe locations. This may increase the risk of pedestrian and vehicle collisions.

**Recommendation:** Revise the location of the pedestrian crossings at this location to ensure that the desired line for pedestrians is catered for.

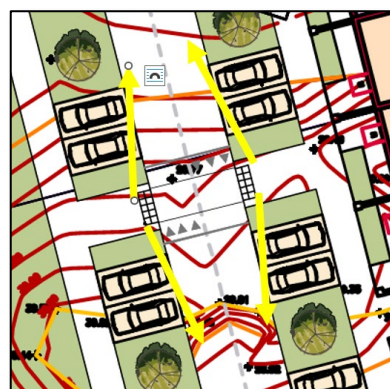
**2.6 Problem:** Pedestrian/Motorist Intervisibility**Location:** House No. 15

A pedestrian crossing is indicated adjacent to house number 15. Car parking bays are indicated either side of the crossing. When vehicles are parked in these bays, it is unclear whether adequate inter-visibility is provided between motorists approaching the pedestrian crossing and pedestrians stopped waiting to cross. While this pedestrian crossing has particularly been highlighted, inter-visibility may also be similarly restricted at other pedestrian crossing locations.

**Recommendation:** Ensure that adequate inter-visibility splays are provided at all pedestrian crossing locations.

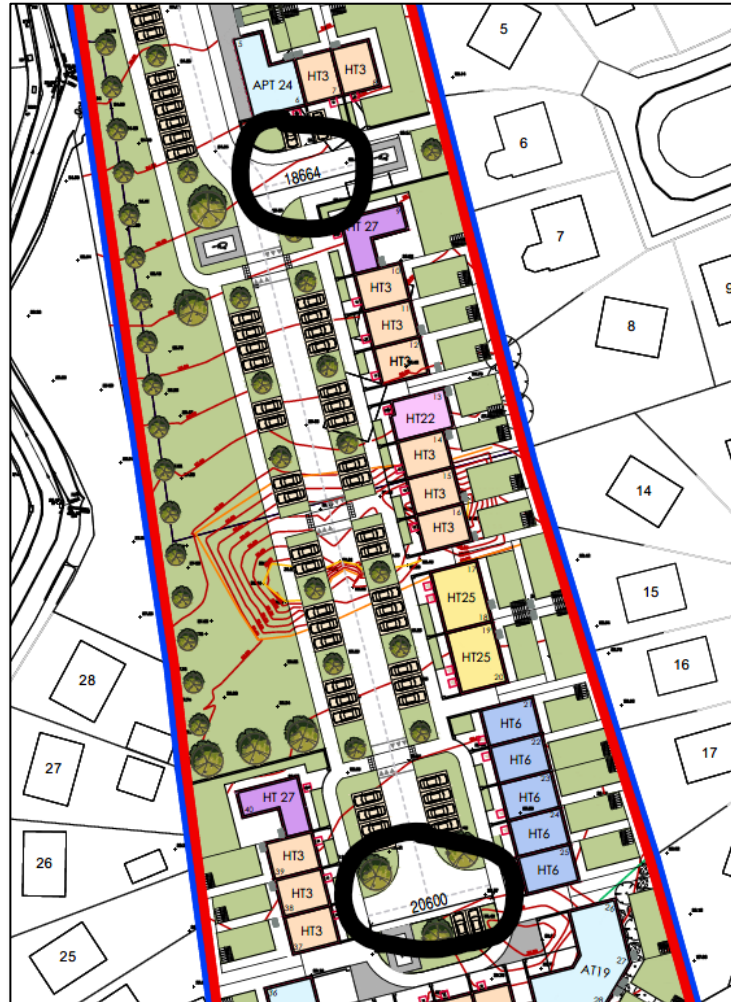
2.7 **Problem:** Reversing Large Vehicles  
**Location:** Throughout

While the access road for the development is long and straight, the turning head at the southern end of the site appears narrow. Larger vehicles such as refuse trucks that enter the development, may not be able to turn. This may result in them reversing over long distances where there would be an increased risk of collisions.

**Recommendation:** Carry out swept path analysis to ensure the current design can cater for larger vehicles.

2.1	Yes	Yes	-----	-----
2.2	Yes	Yes	-----	-----
2.3	Yes	Yes	-----	-----
2.4	Yes	Yes	-----	-----
2.5	Yes	Yes	-----	-----
2.6	Yes	Yes	-----	-----
2.7	Yes	No	The proposed turning heads have been designed based on the guidance provided in Recommendations for Site Development Works for Housing Areas issued by the Department of the Environment and Local Government. Turning heads designed to meet the minimum requirements outlined in this document will be deemed to provide adequate turning area for Vehicles up to the size of a Furniture Removal lorry without the necessity to carry out a swept path analysis as confirmed in email dated 07/02/25.	Yes

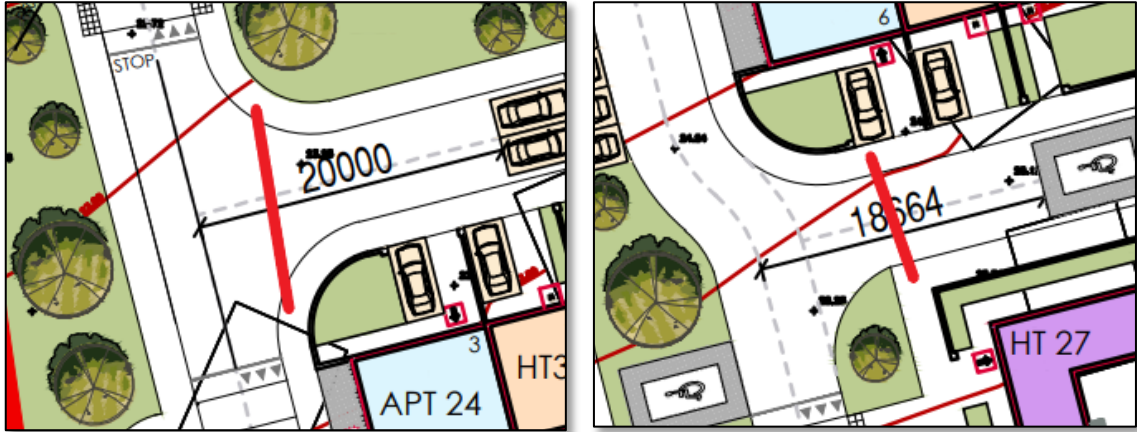
**2.9 Problem: Pedestrians Crossing at Unsafe Locations****Location:** Adjacent to House No. 3 and 6

A pedestrian footpath is indicated around the cul-de-sacs; however, its placement does not align with the preferred path for pedestrians. Insufficient crossing facilities along pedestrian desire lines could result in individuals crossing at full-height kerbs or unsafe areas.

**Recommendation:** Revise the layout of the footpaths to ensure that the desired crossing line for pedestrians is catered for.

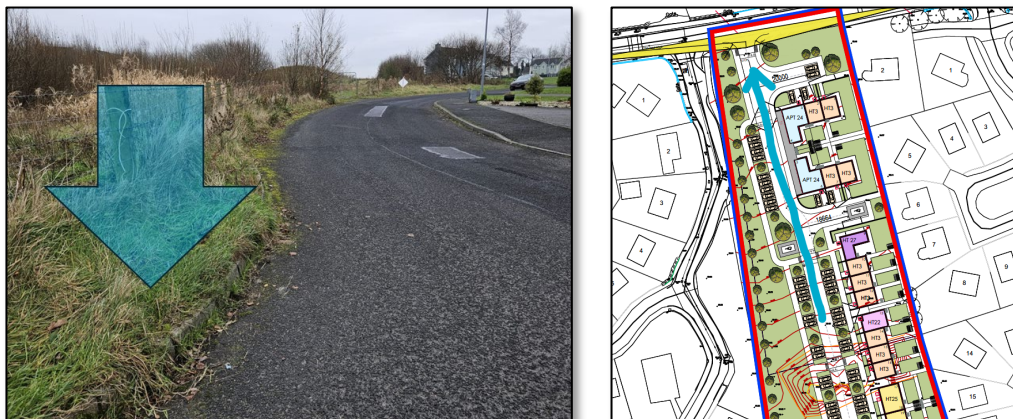
**2.10 Problem: Drainage and Site Runoff****Location:** Throughout

The design drawings do not indicate a proposed drainage system. The natural topography of the ground indicates a decline from the south of the site to the north. Surface water from the development will flow towards the main entrance and onto the L2501 road. In times of prolonged or heavy rain, flowing water may cause cyclists or motorists to make sudden manoeuvres resulting in collisions.

**Recommendation:** Ensure adequate surface drainage is provided as part of the development.
