Dunree Fort Project

Built Heritage Impact Assessment

Issue: PLANNING APPLICATION STAGE: Rev C – 4th October 2023

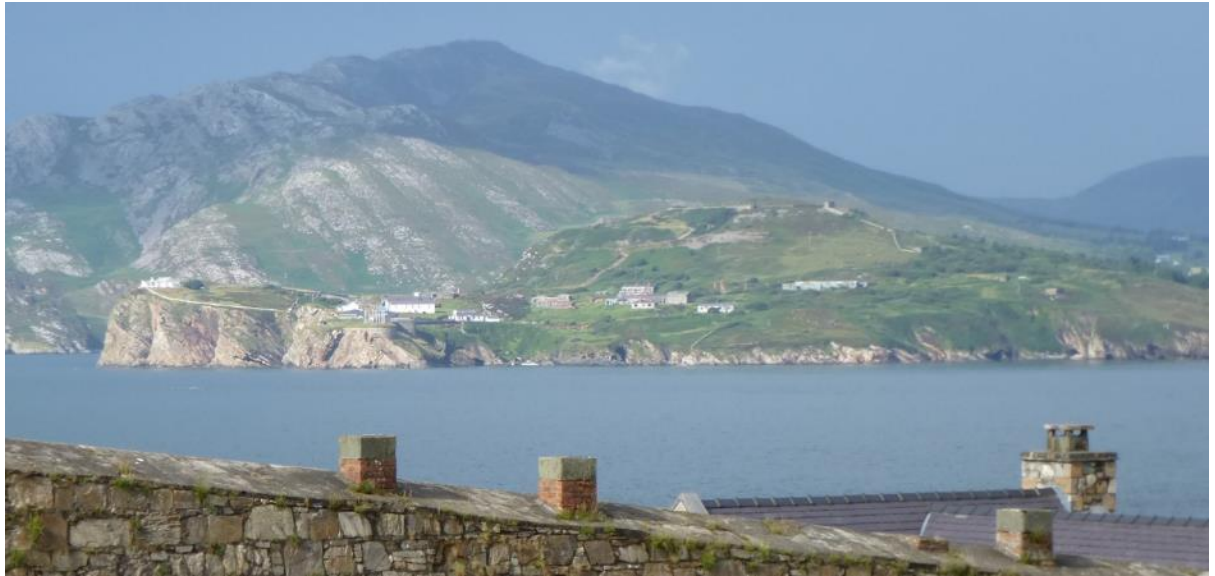
Figure 2 – Dunree Fort & Dunree Hill Battery & Redoubt Fort viewed from Knockalla (2013)

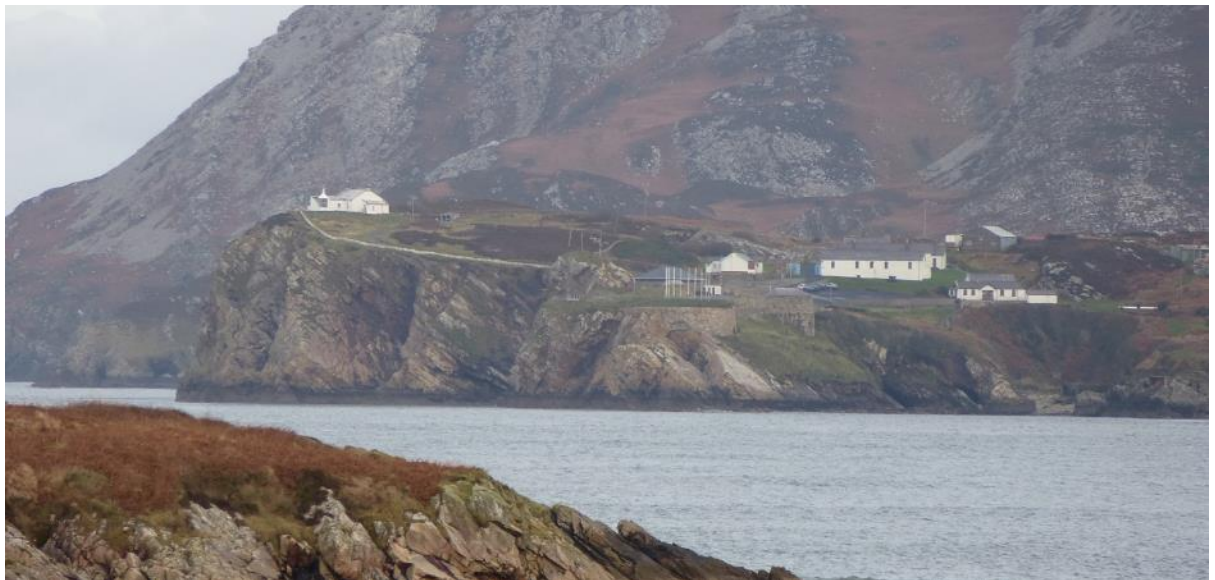
Figure 3 – view of Dunree Fort & lighthouse from Knockalla (2013) (Dunree Fort constructed circa 1810; reconstructed circa 1895)

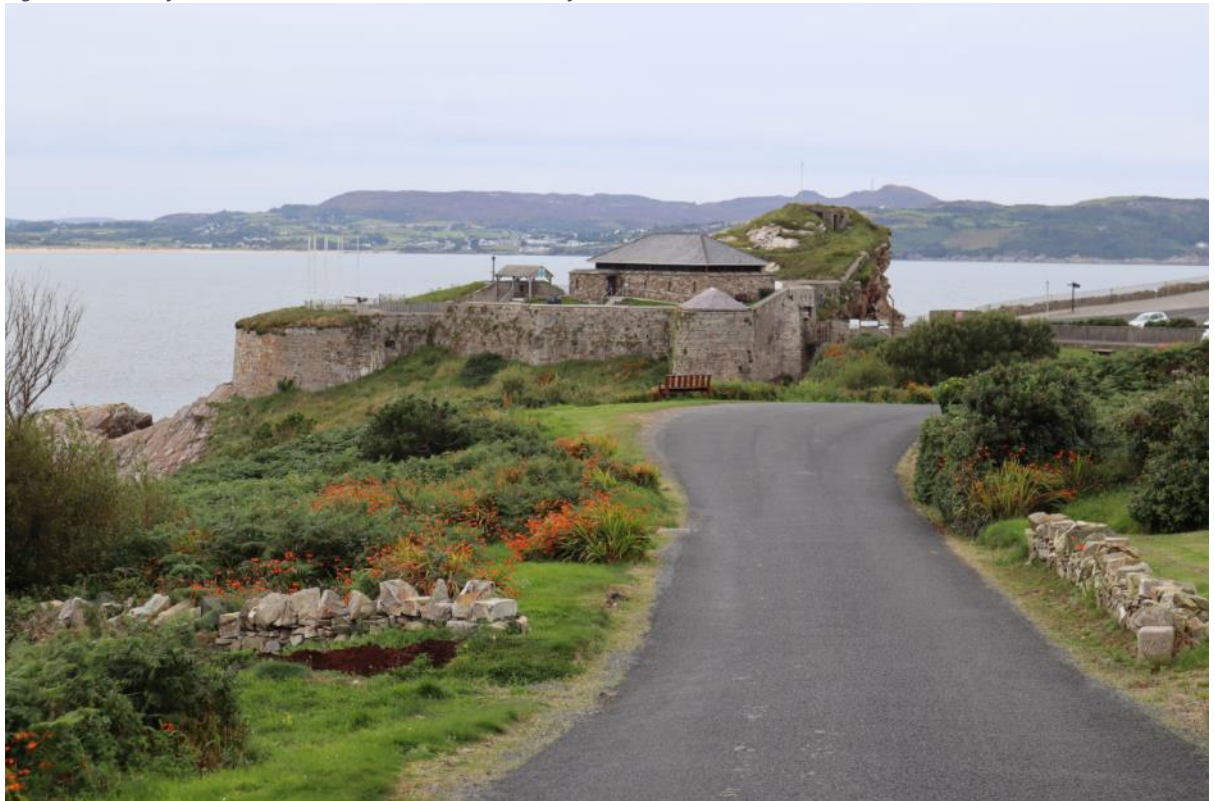
Figure 5 – view of Dunree Fort from south; hipped roof structure & shelter are modern additions affecting the character and visual interpretation of the gun-emplacement; otherwise, structures are substantially as reconstructed and re-armed circa 1895

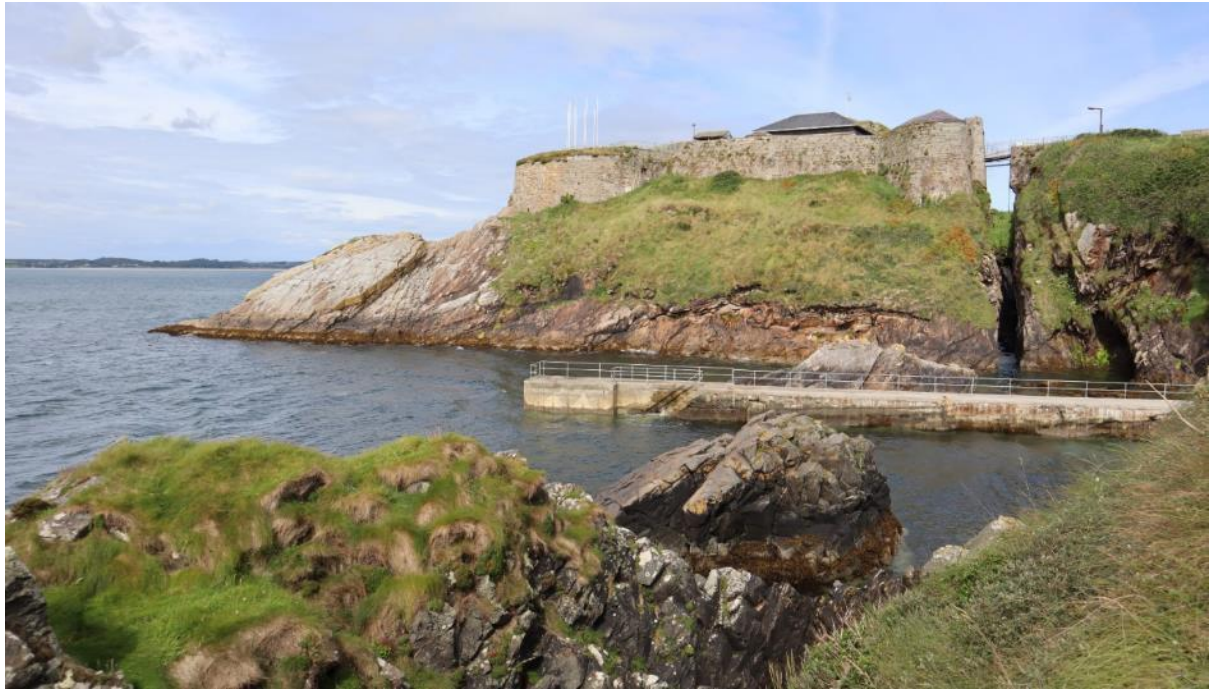
Figure 6 – view of Dunree Fort from south; large masonry bastions and revetments are as constructed circa 1810

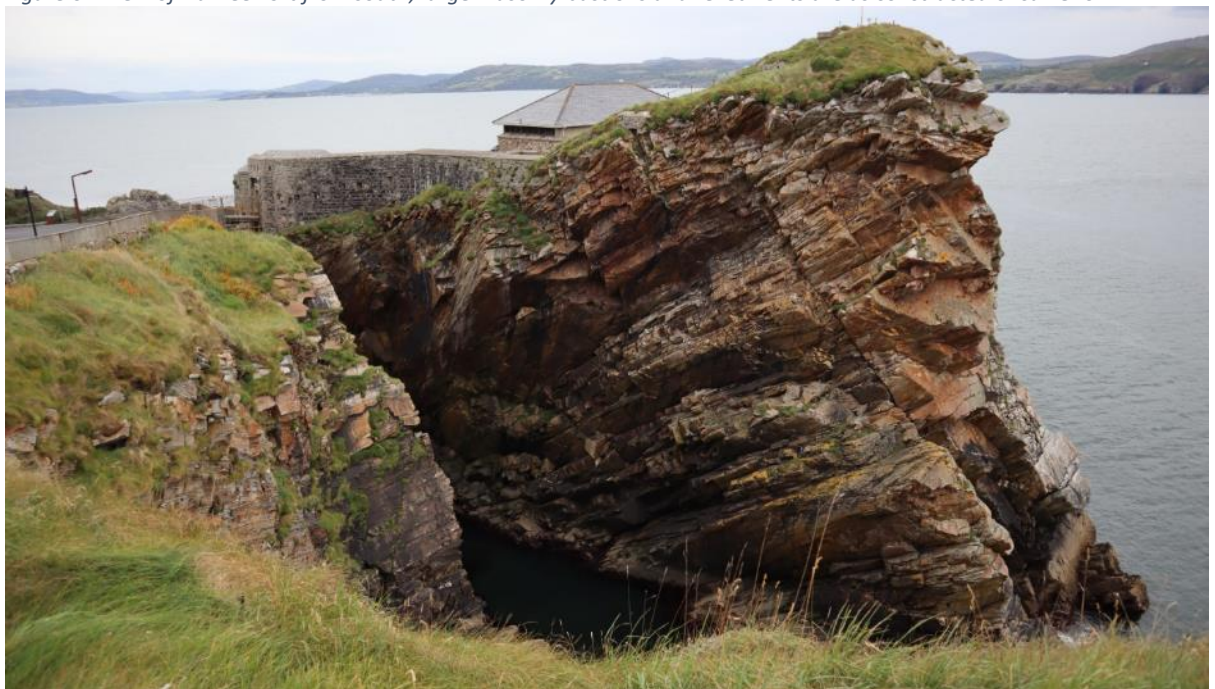
Figure 7 – view of Dunree Fort from north; large masonry sections are as constructed circa 1810; the original Martello tower and soldiers' accommodation were removed circa 1895 as part of remodelling in conjunction with development of Dunree Hill Battery & Redoubt Fort. Structures visible above the curtain wall were not part of this view post circa 1895.

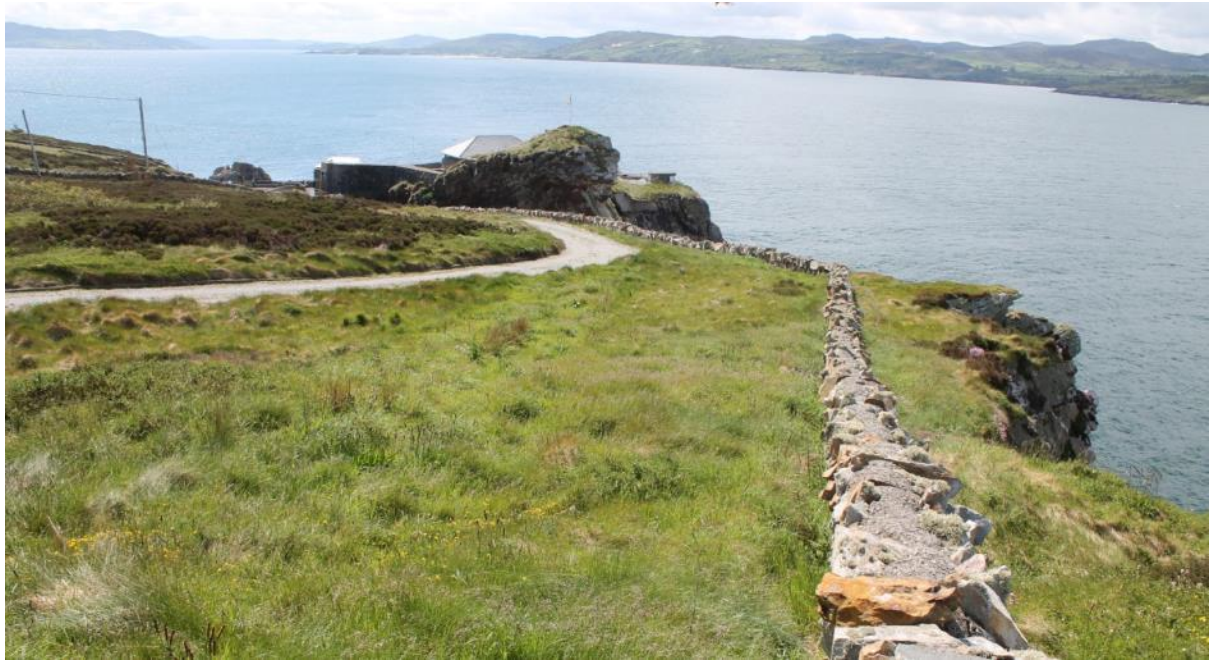
Figure 8 – view of Dunree Fort from the lighthouse grounds to the north

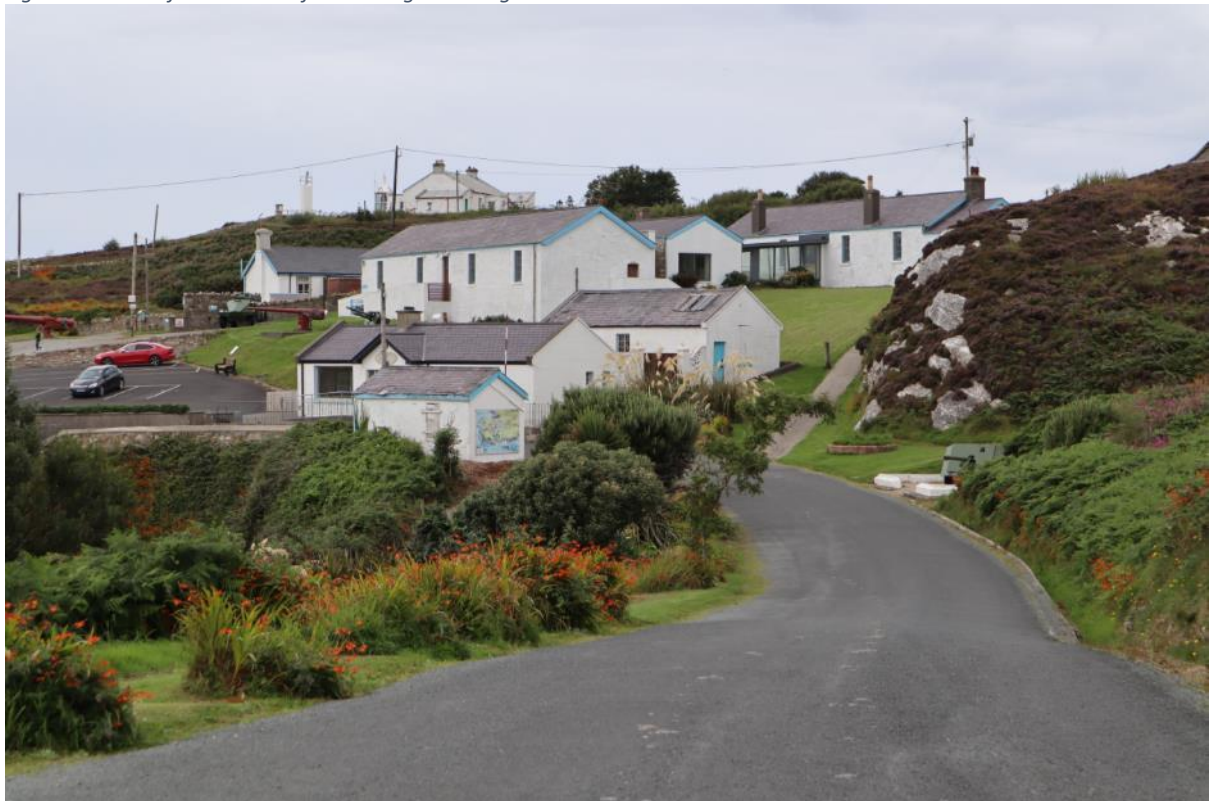
Figure 9 – view of first 'hutment' built circa 1895 to coincide with remodelling of the Dunree Fort & construction of the Dunree Hill Battery & Redoubt Fort

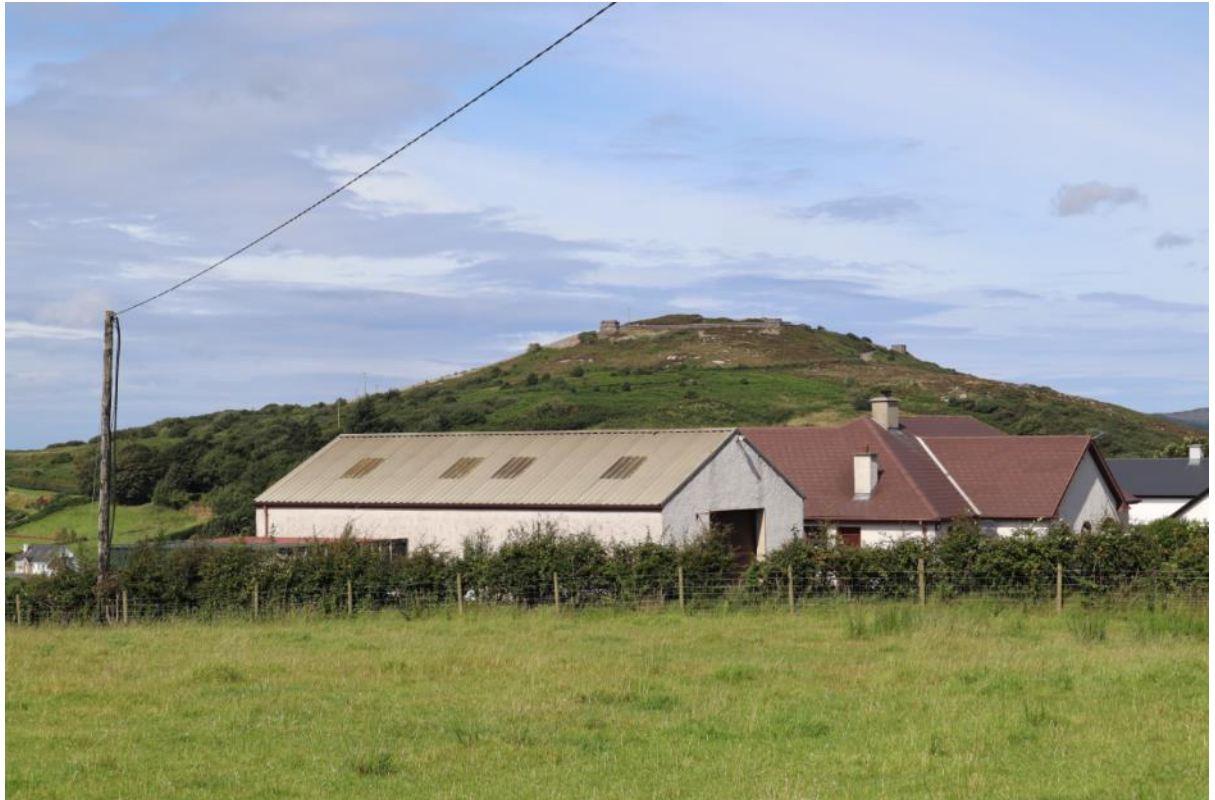
Figure 10 – view of 1895 Dunree Redoubt Fort from Inishowen 100/ Wild Atlantic Way route from south

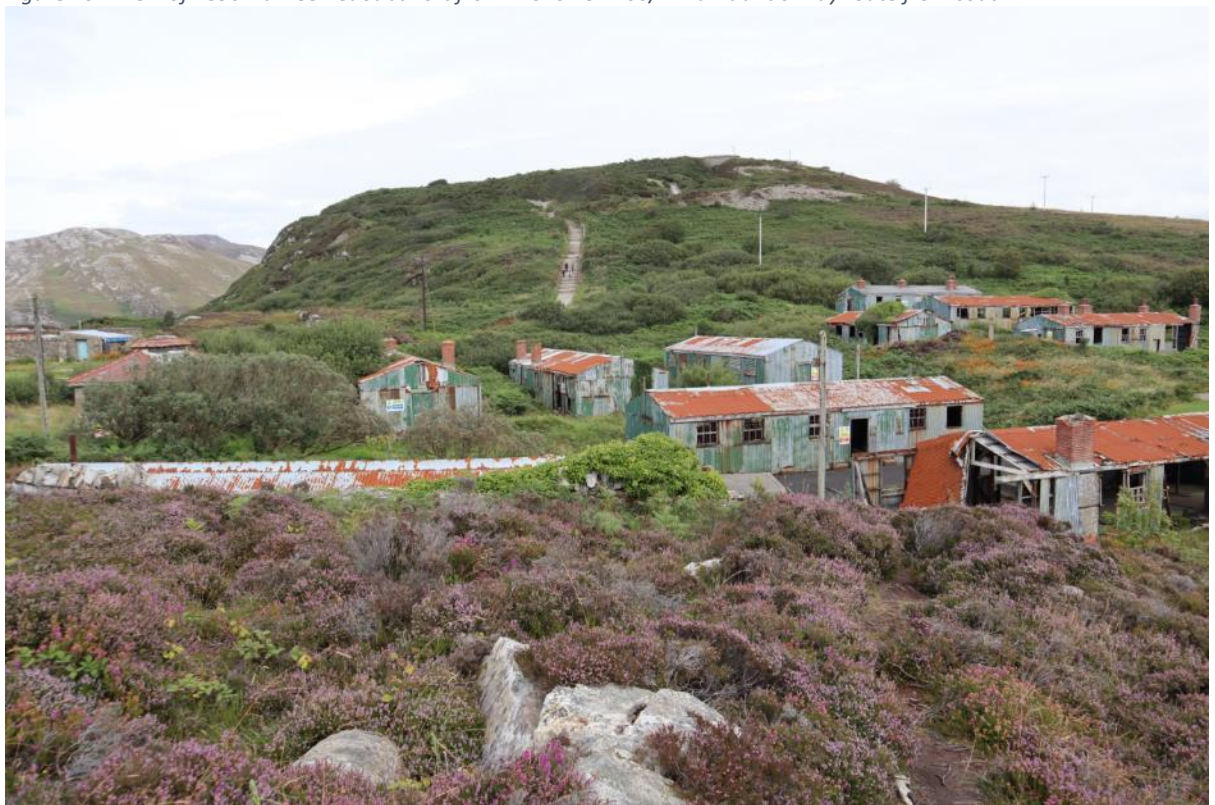
Figure 11 – view of 'hutment' towards Dunree Hill & Redoubt Fort; the iron clad timber hutment on the former camping grounds expanded mostly circa 1902 to 1912 to serve the expanded artillery base & further reinforcement during WW1

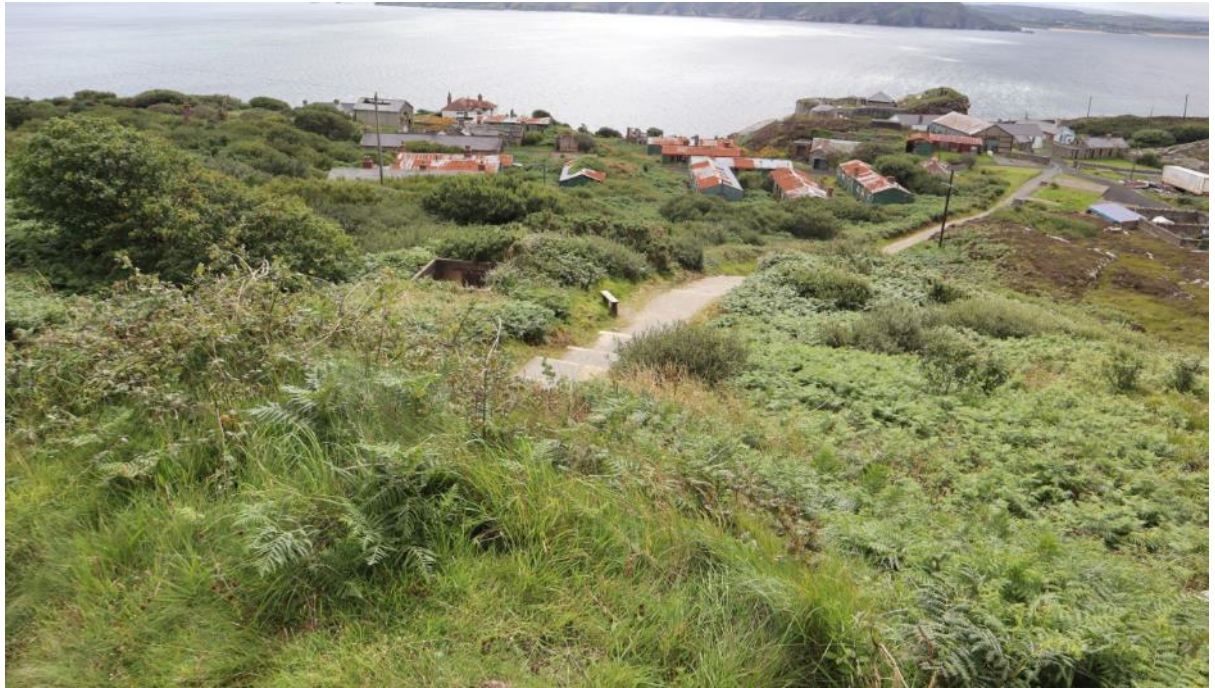
Figure 12 – view of the expanded 'hutment' from Dunree Hill

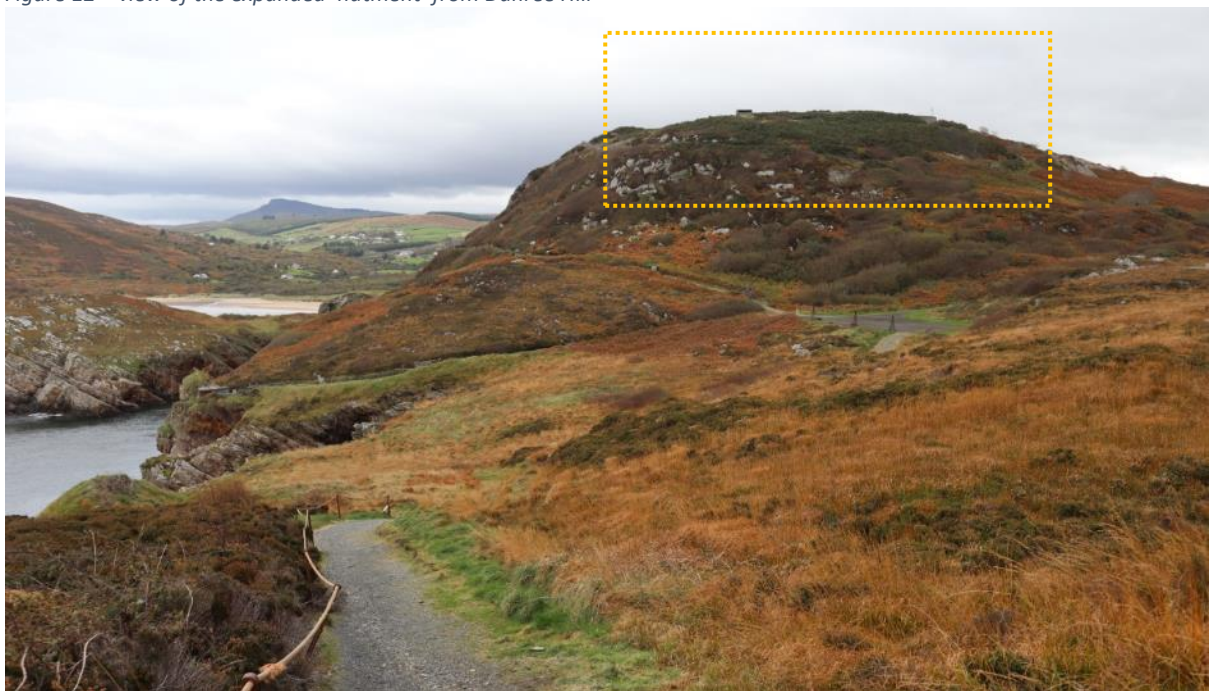
Figure 13 – view of Dunree Hill Redoubt Fort & Battery gun-emplacement from east side of lighthouse hill; the former Practice Battery is located in the right centreforeground

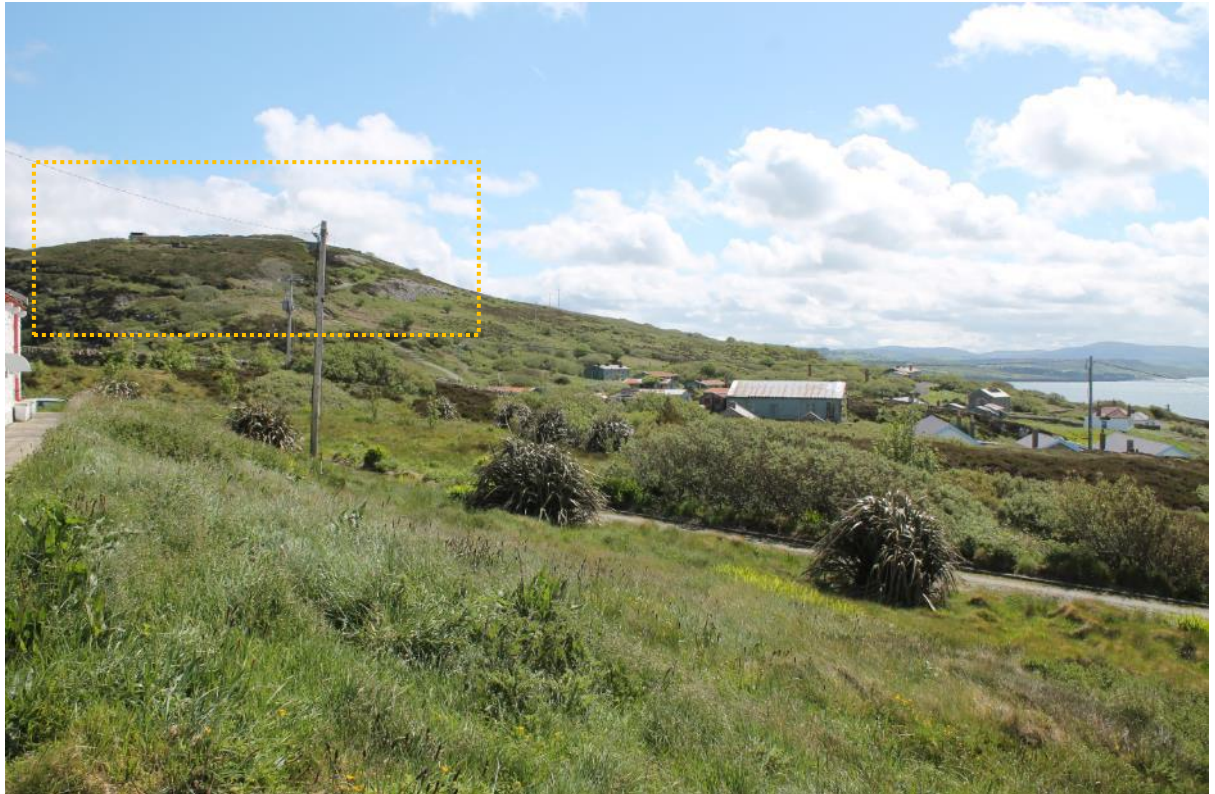
Figure 14 – view of 1895 Dunree Redoubt Fort from grounds of Dunree lighthouse

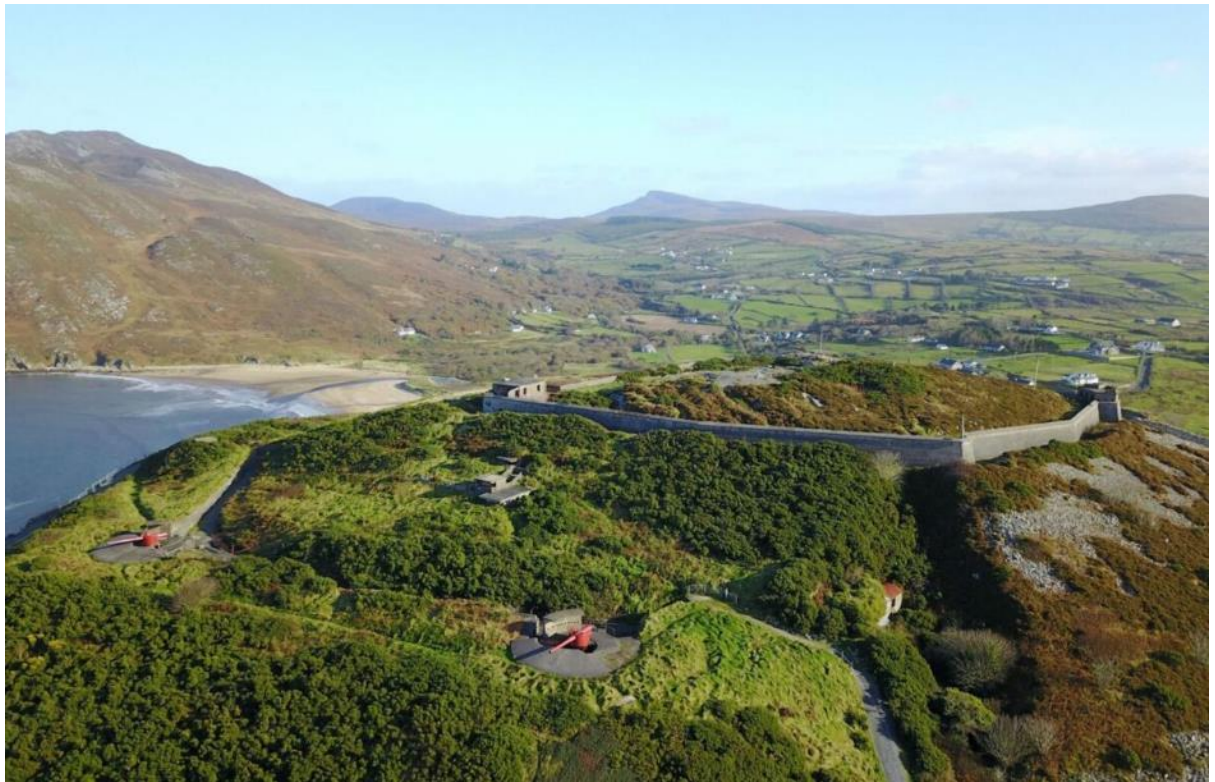
Figure 17 – elevated view of hill battery & redoubt fort; the structure largely unchanged since circa 1900
Image: © Donegal Daily

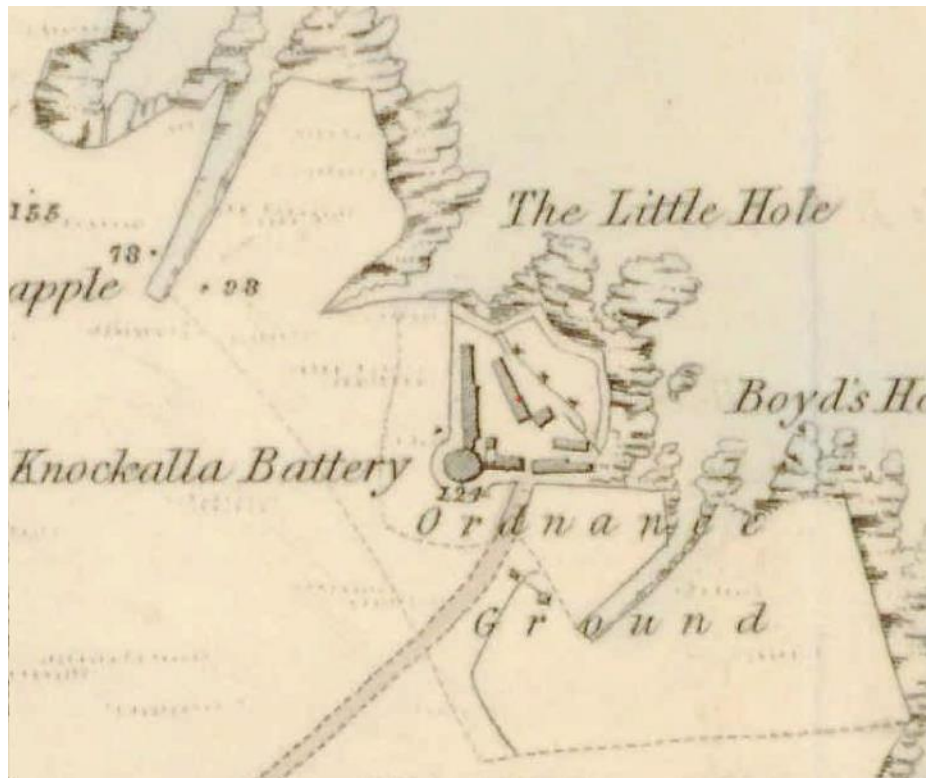
Figure 20 – 1st Edition Ordnance Survey map (c1840) showing Knockalla Battery, Lough Swilly: current use private house © OSI

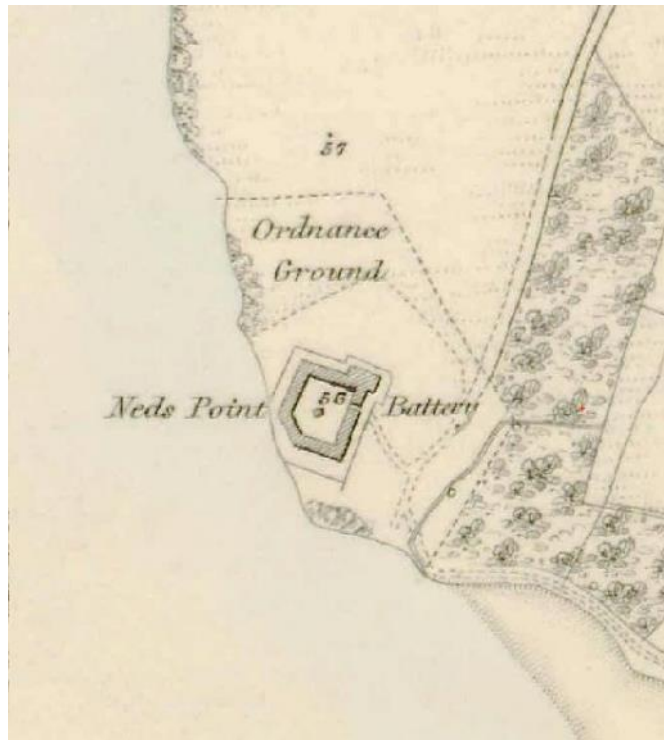
Figure 22 – 1st Edition Ordnance Survey map (c1840) showing Ned's Point Battery, Buncrana, Lough Swilly; substantially altered circa 1895; currently disused © OSI

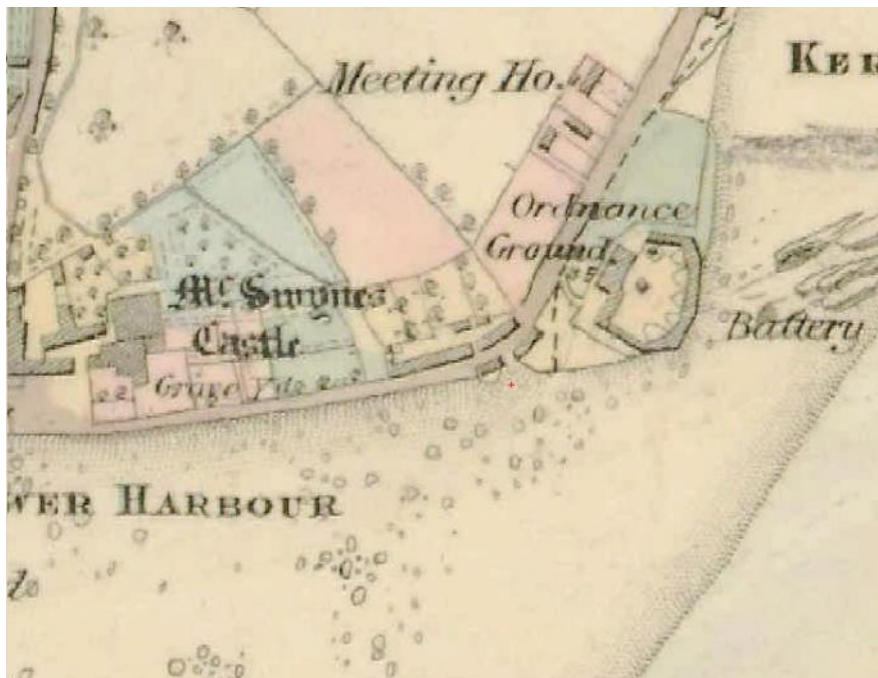
Figure 23 – 1st Edition Ordnance Survey map (c1840) showing Rathmullan Battery, Lough Swilly current use museum © OSI

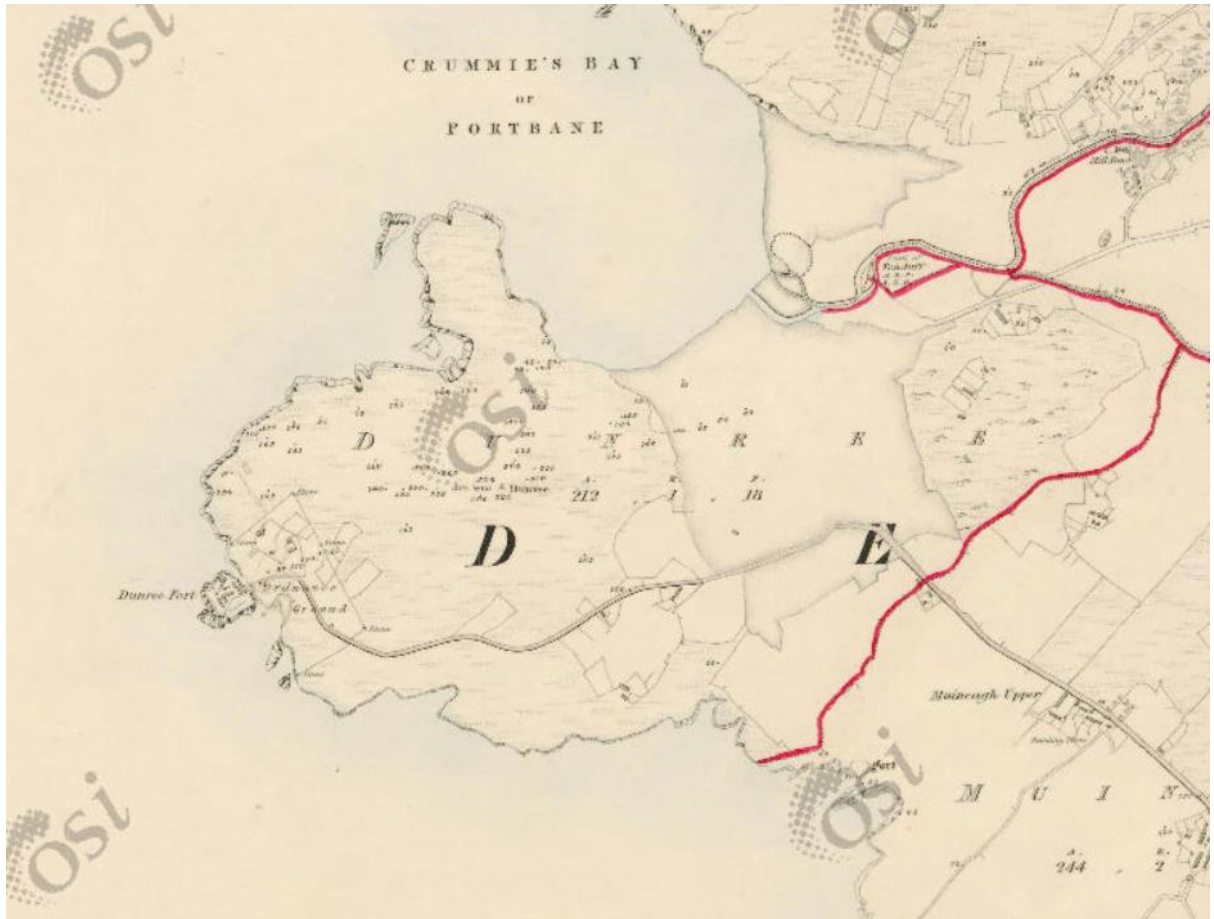
Figure 27 – 1st edition Ordnance Survey map (c.1835) – overview of townland of Dunree. © OSI

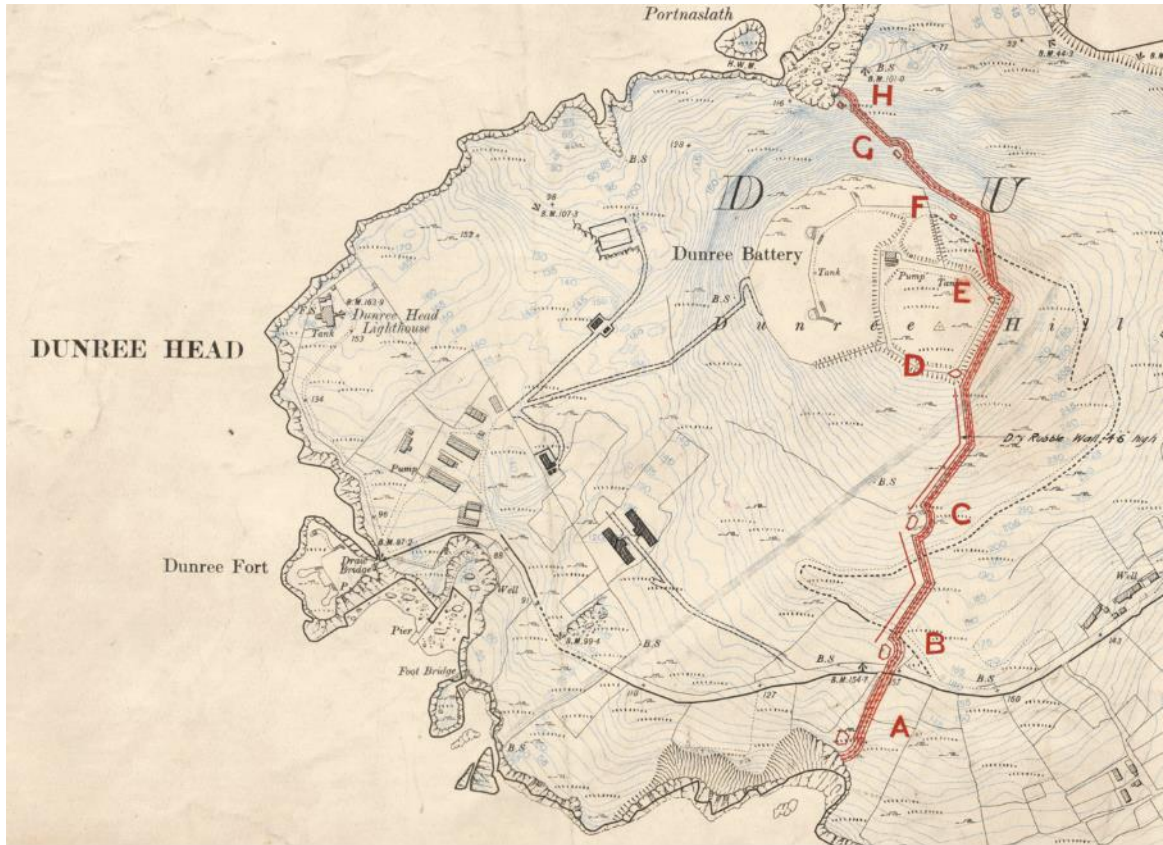
Figure 43 – drawing of additional defences to the Dunree Hill Battery & Redoubt fort; drawn 1915. These are the concrete blockhouses along the eastern/ landward side of the site ©UK National Archives

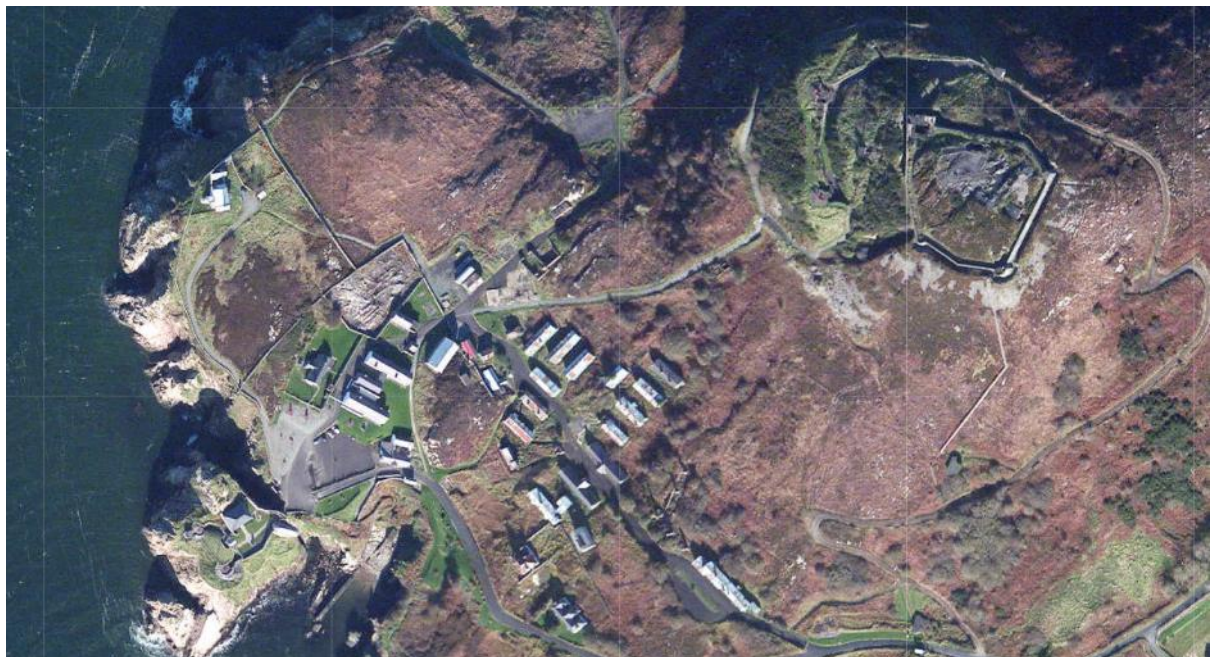
Figure 46 – Aerial view showing the current layout © DigitalGlobe Inc.

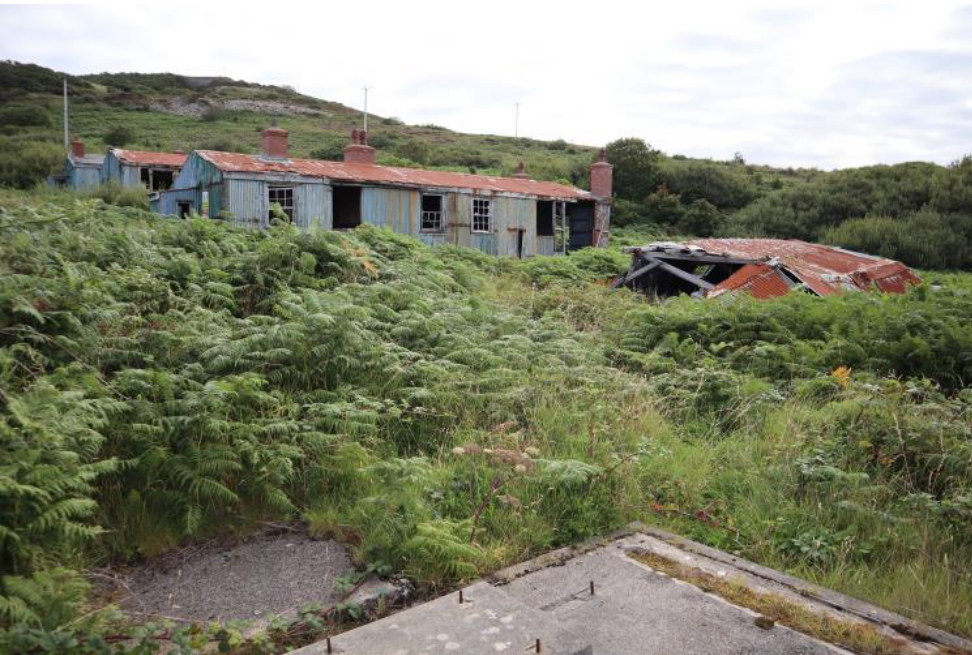
Figure 88 - 7.07 Hut 7 – Gymnasium(collapsed)

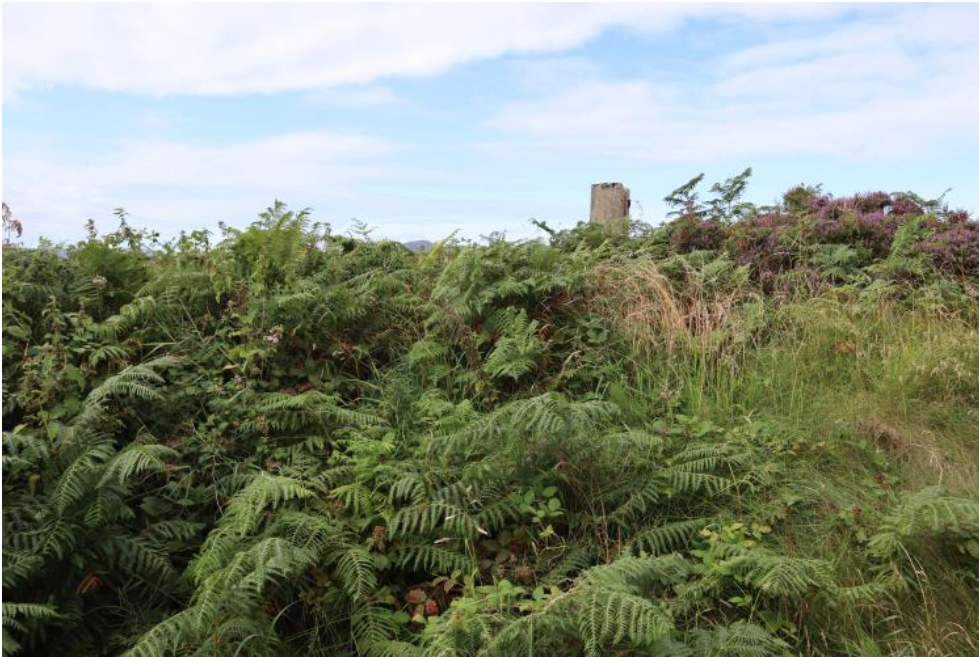
Figure 91 – 9 Flagpole (base only)

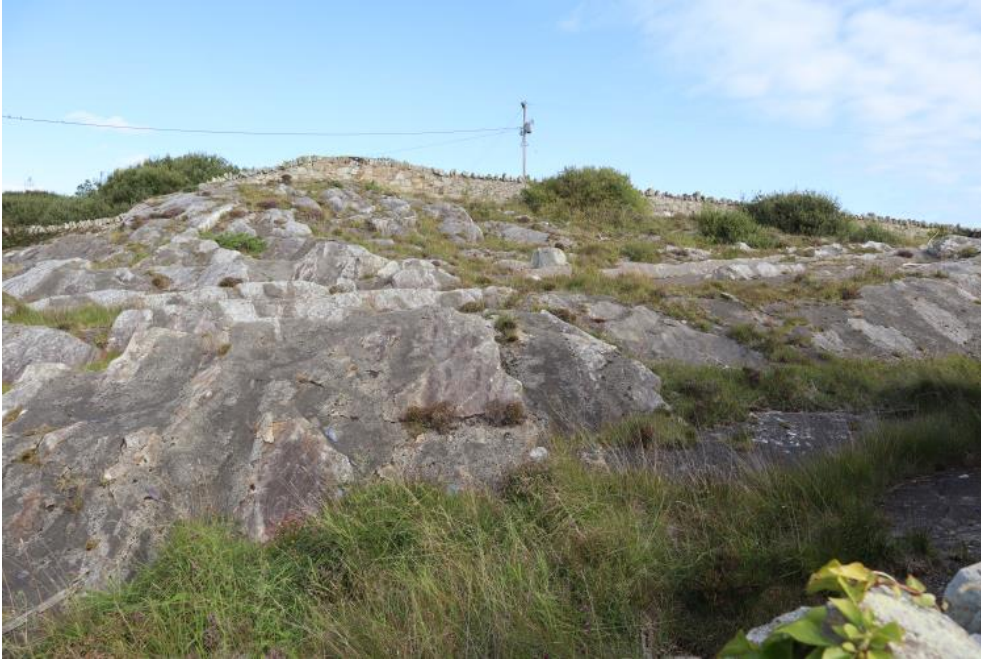
Figure 123 – 27.04 Water Catchment Area

27.04	Water Catchment Area	Ordnance ground Hutment			High	Requires maintenance	No work proposed this phase	Future repairs anticipated in Conservation Plan	None

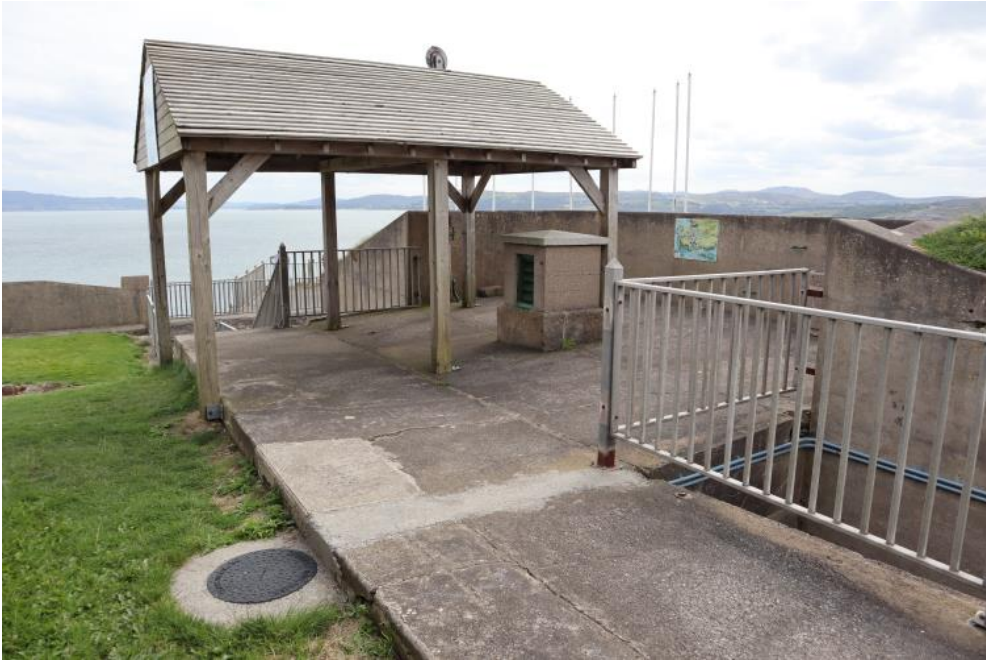
Figure 136 – 31.08 Magazine/ Shell Store

31.08	Exhibit/ Group Store	Dunree Fort			Low		No work proposed this phase	Future repairs anticipated in Conservation Plan	None
31.09	Magazine/ Shell Store	Dunree Fort			High		No work proposed this phase	Future repairs anticipated in Conservation Plan	None
32	Pier

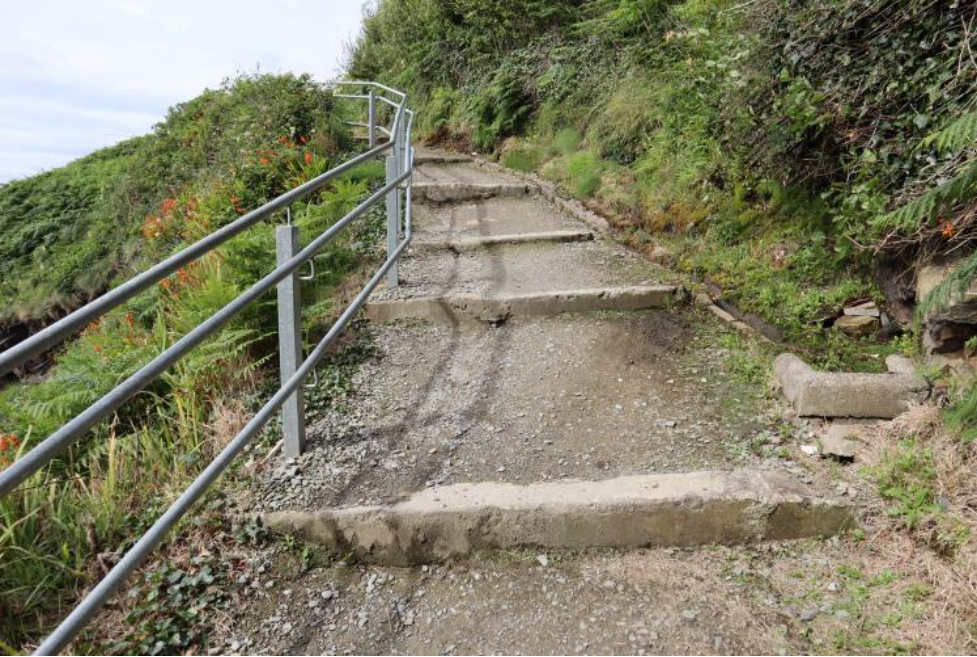
Figure 139 – 32.02 Pier Stairway

32.02	Stairway	Ordnance ground			Moderate	Requires maintenance	No work proposed this phase	Recommend short term maintenance to facilitate visitor safety	None

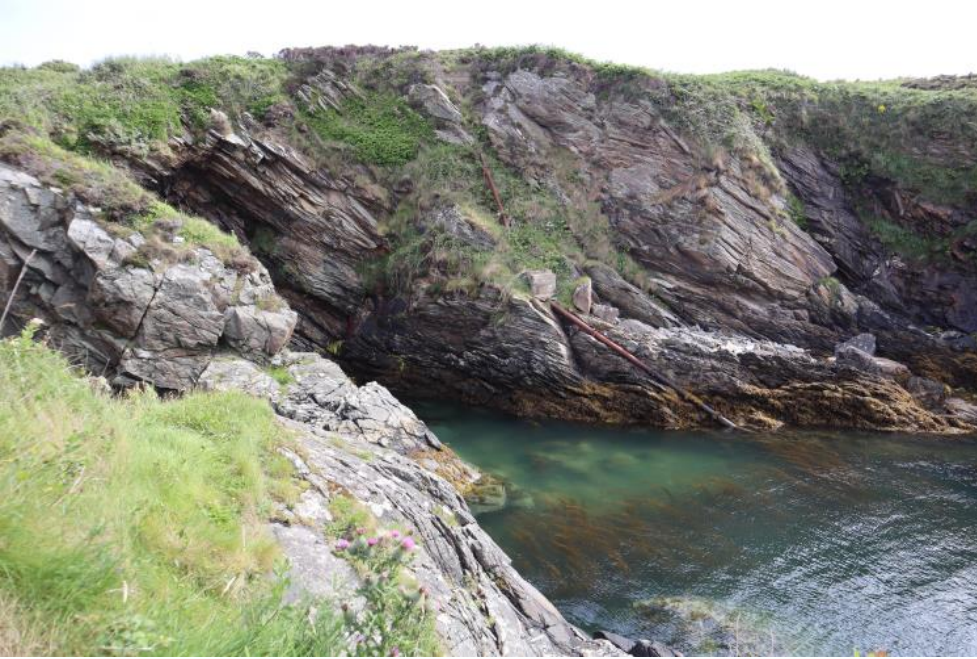
Figure 141 – 33.02 Fixed Beam Searchlight

33.02	Fixed Beam Searchlight Emplacement	Ordnance ground		18" concrete walls; 12" concrete roof to falls - tarred on top; intermediate steel beams; 4" concrete slab floor	High	At Risk	No work proposed this phase	Future repairs anticipated in Conservation Plan	None

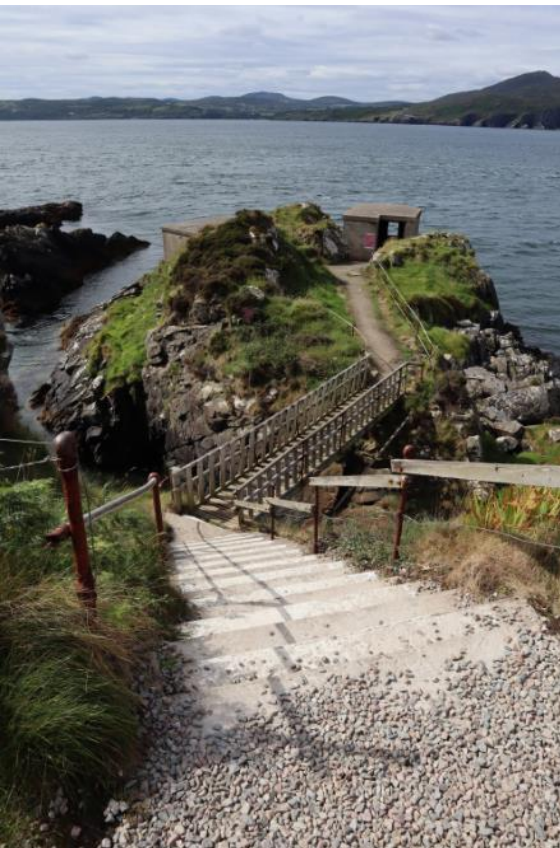
Figure 142 – 33.03 Bridge & 33.04 Stairway

33.04	Stairway	Ordnance ground			Moderate	At Risk	No work proposed this phase	Future repairs anticipated in Conservation Plan	None
34	Practice Battery

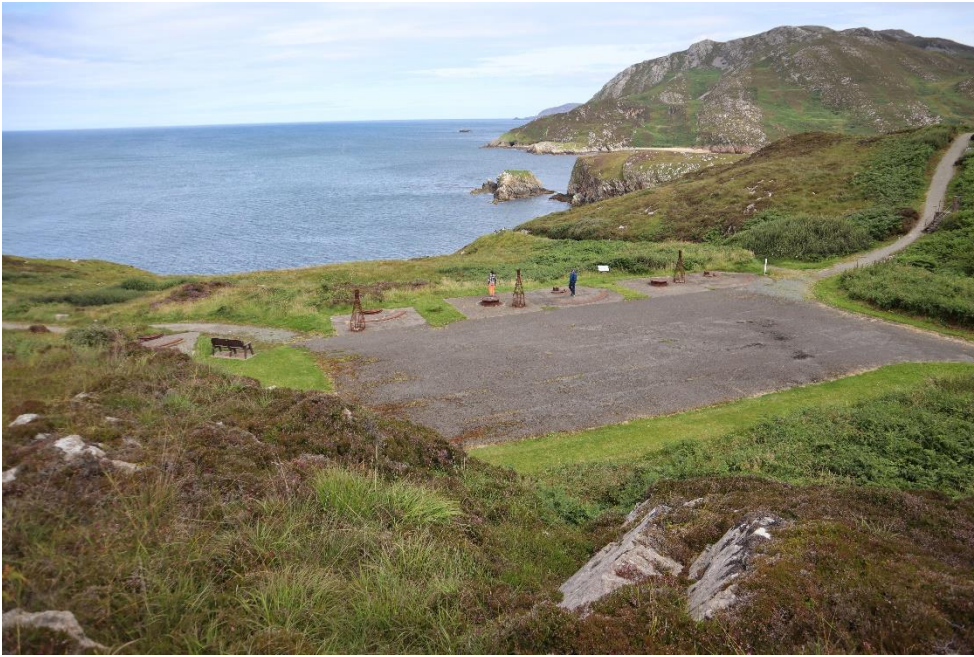
Figure 143 – 34.01 Practice Battery

34.01	Gun platform	North lower hillside			High	Requires maintenance	No work proposed this phase	Future repairs anticipated in Conservation Plan	None
34.02	DRF Posts	North lower hillside	Depression range finder		High	Requires maintenance	No work proposed this phase	Future repairs anticipated in Conservation Plan	None

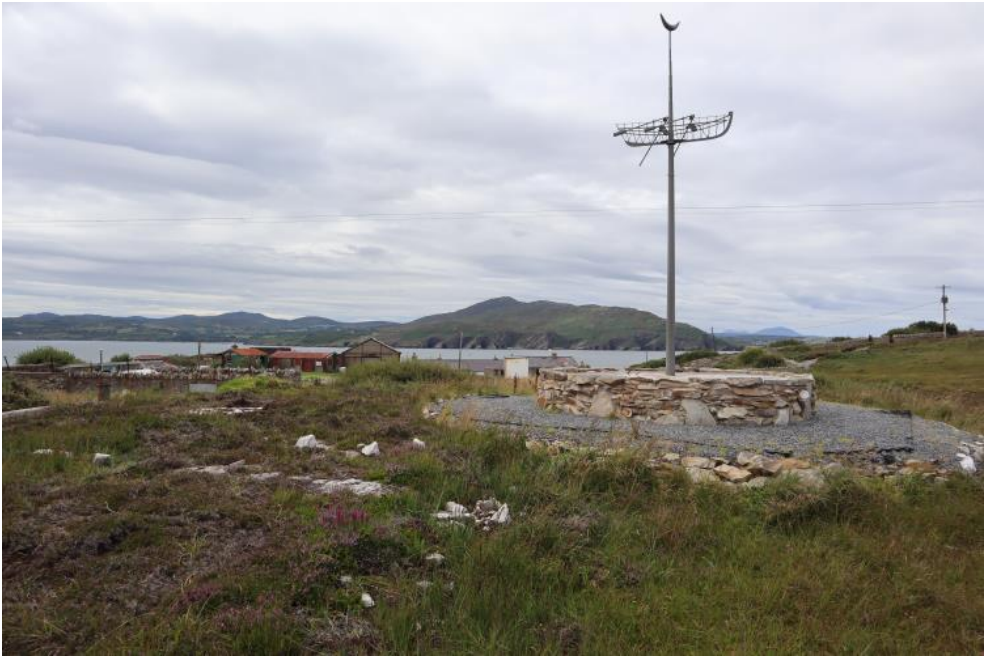
Figure 145 – 34.04 Laurentic Memorial

34.03	Helipad/ former Tennis Court	North lower hillside			Low		No work proposed this phase	Future repairs anticipated in Conservation Plan	None
34.04	Laurentic Memorial	North lower hillside			Low	Requires maintenance	No work proposed this phase	Future relocation anticipated in Conservation Plan	None
