Dunree Fort Project

Built Heritage Impact Assessment

Issue: PLANNING APPLICATION STAGE: Rev C – 4th October 2023

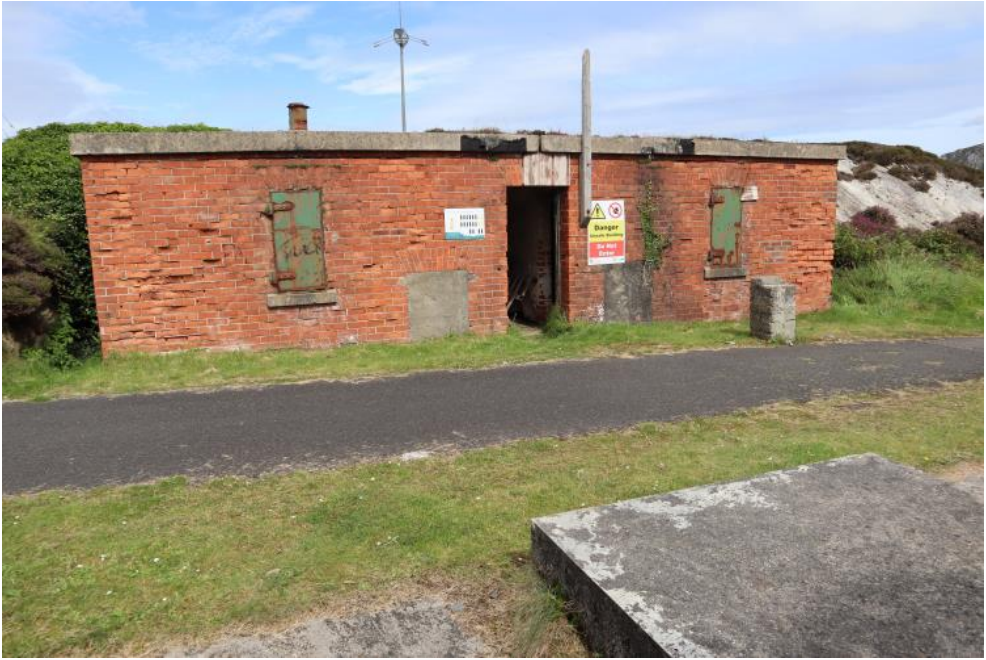
Figure 146 – 34.05 Practice Range Magazine Store

34.05	Practice Range Magazine Store	North lower hillside	Shell store, cartridge store, shifting lobby; adjacent RA store not present	16" brick cavity wall; 6" concrete slab floor; 9" concrete slab roof to falls; 3/4" asphalt finish (tarred on top according to WO 78_4910_003); door sheeted 1/8" iron	High	At Risk	No work proposed this phase	Propose short term access control measures - Future repairs anticipated in Conservation Plan	None

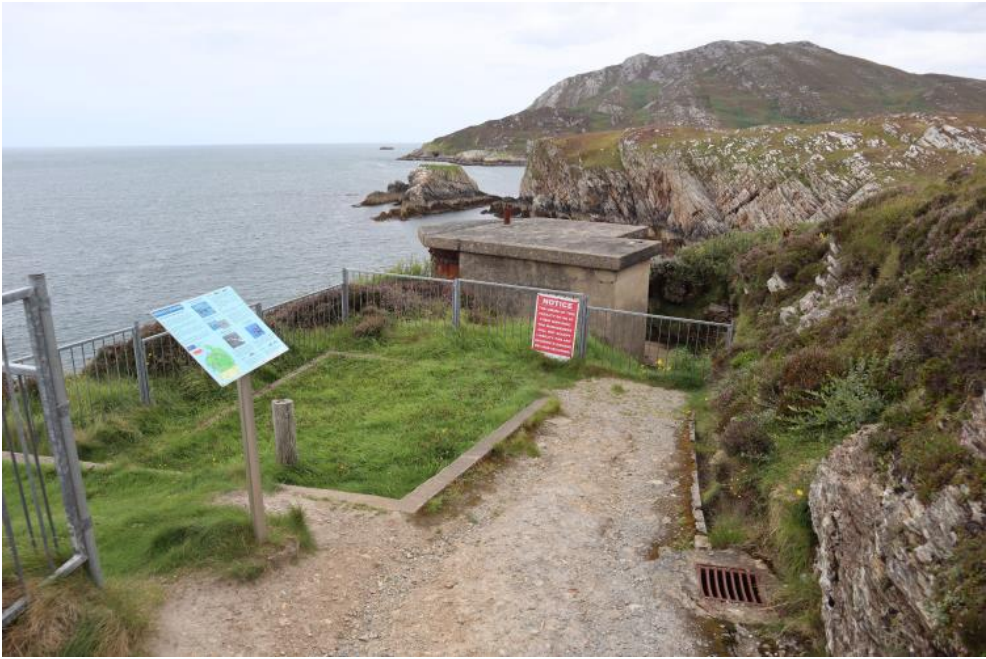
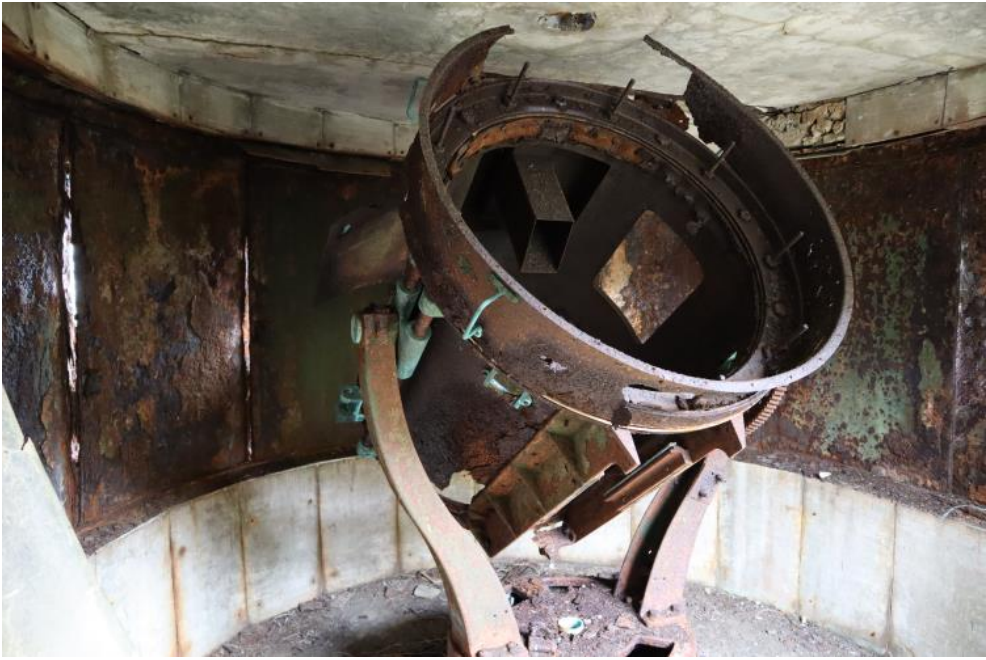
Figure 147 – 34.06 Moveable Searchlight Emplacement

34.06	Moveable Searchlight Emplacement	North lower hillside		Concrete with flat concrete roof; sliding steel shutters	High	At Risk	No work proposed this phase	Propose short term access control measures - Future repairs anticipated in Conservation Plan	None
35	Rifle Range	South lower hillside			Low	Demolished - Rising walls & base only	No work proposed	Outside current site area	n/a
36	Lighthouse & Light Keeper's Cottage	Irish Lights ground			High	Requires maintenance	Development of new use to former Lightkeeper's house currently disused	Develop proposals & method statement for review during detail design phase - review extent of demolition proposed to form new opening to connect from & back rooms for exhibition space; wide doorway recommended	Moderate/beneficial
