Proposed demolition of existing leisure centre building.

Buncrana, Co Donegal

Bat Survey and Assessment Report

08/03/2023

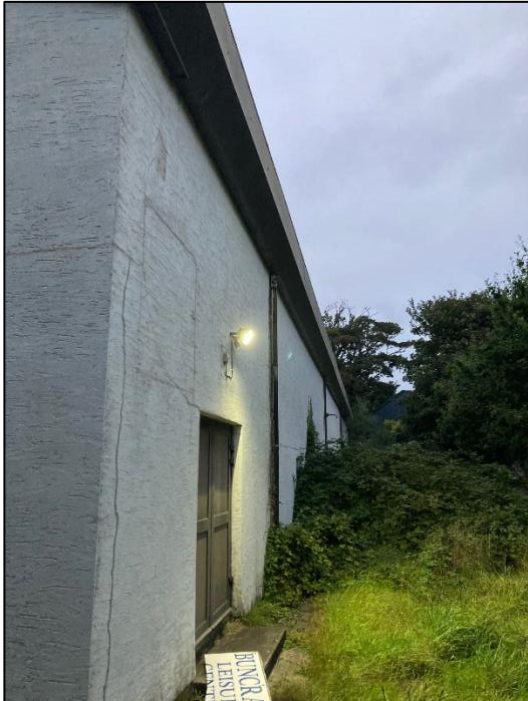
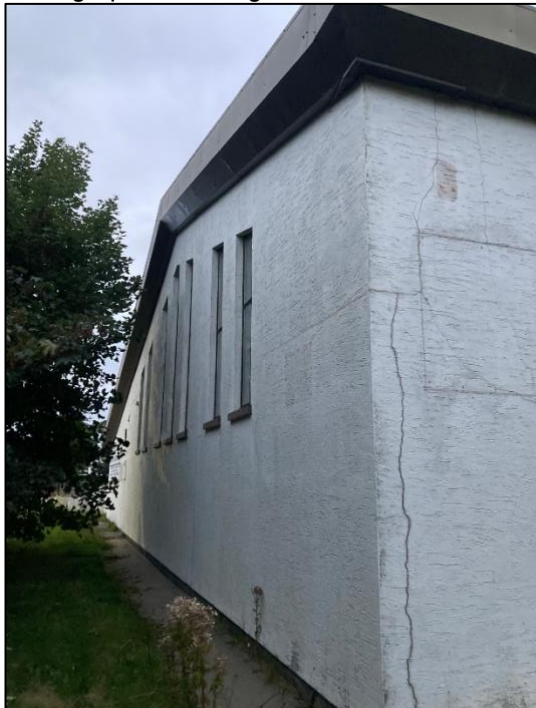
- 1.17 Photographs 1-2 in appendix 2 show the existing leisure center. The site consists of an intact leisure center in delapidated condition. There was bat roost potential within the building and internal space. The leisure centre space and structure was suitable to house a moderate numbers of bats and could potentially hold a maternity roost. The site was covered in overgrown vegetation.

Photograph 1 Existing leisure centre

Photograph 2 Existing leisure centre

- 1.22 The leisure centre was classed as having moderate potential for roosting bats based on the bat roost potential survey carried out prior to full survey. There is moderate spaces within the leisure centre attic space which could hold individual or moderate numbers of bats. The leisure centre was in a dilapidated condition with potential emergence/re-entry points identified. There was moderate roosting potential for bats within the leisure centre either in the attic space or within the structure of the walls despite the delapidated condition.
- 1.23 No bats were recorded roosting within the leisure centre.

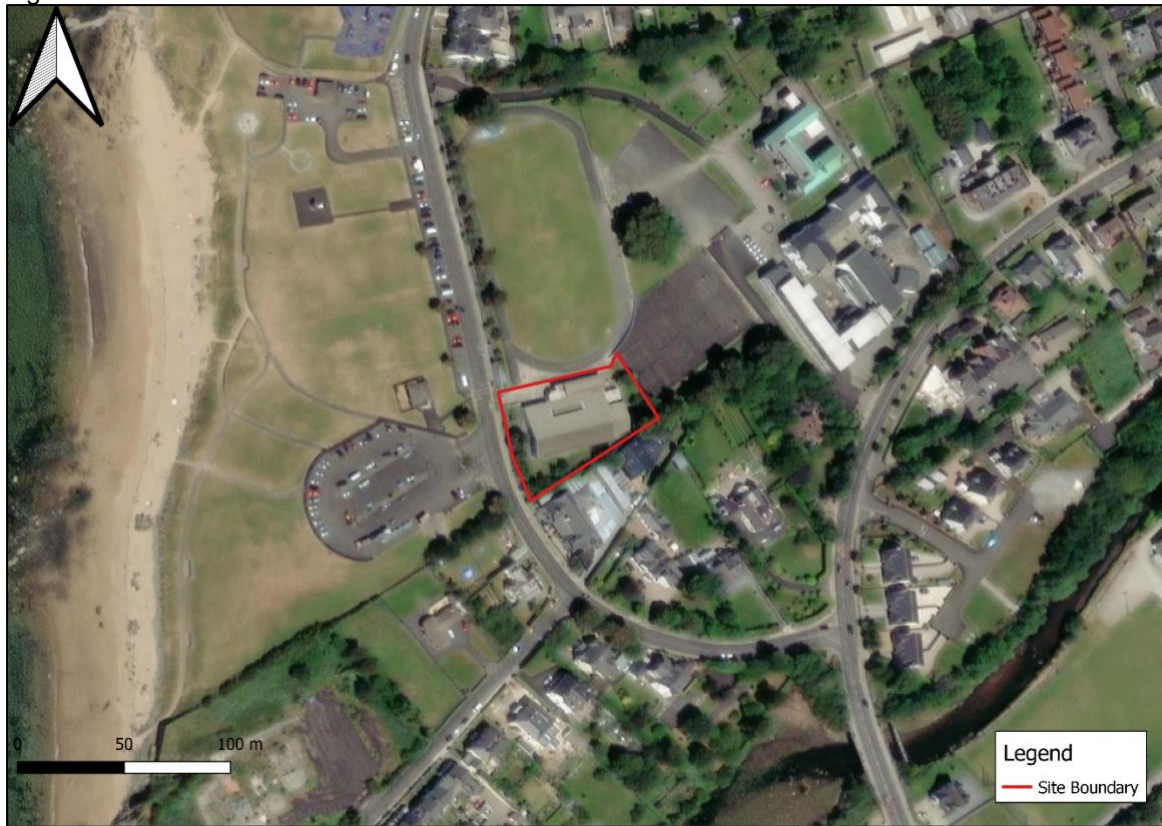
Figure 1 Site Location and Habitat

- 1.16 The proposed site is within an urban setting (see figure 1 at appendix 3). There are some mature trees within and next to the boundary of the site that may be felled as part of the planned development. Bat habitat quality was assessed as being moderate. Mature trees potentially planned for felling near the buildings were taken into consideration and viewed as part of the VPs.

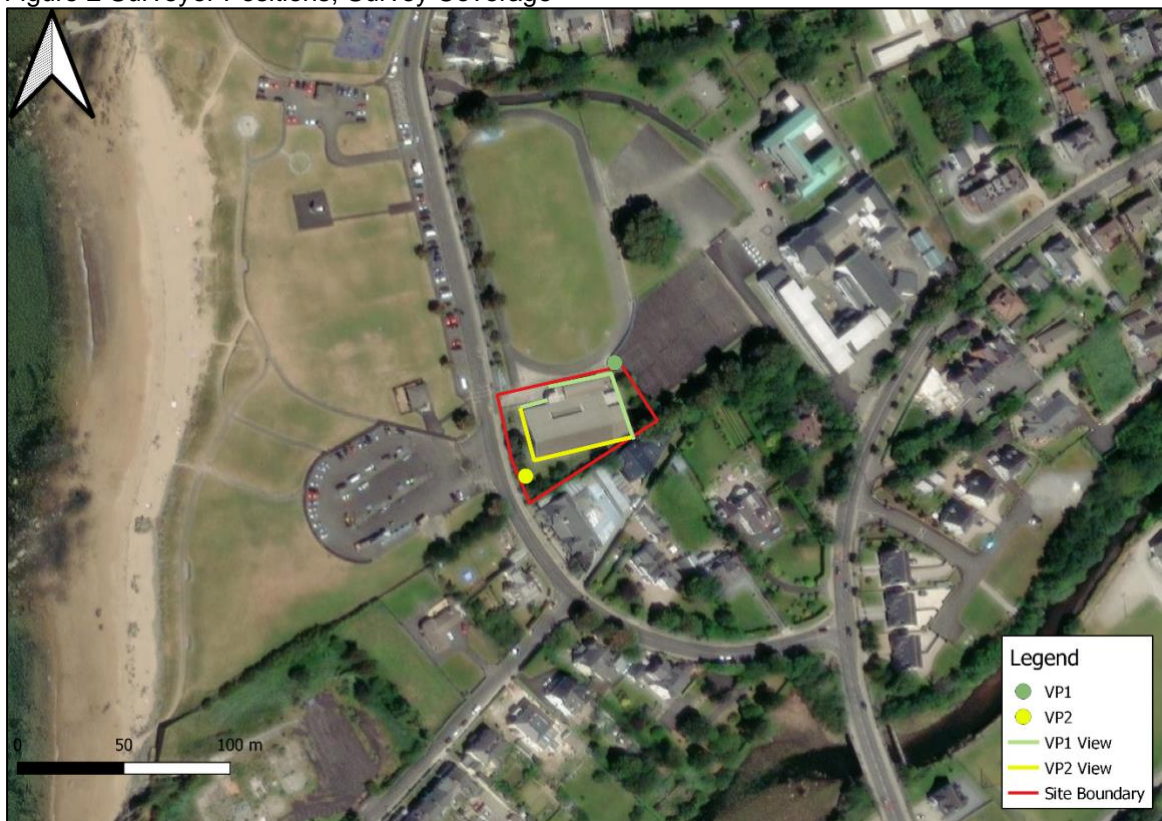
Figure 2 Surveyor Positions, Survey Coverage

the VPs as per guidelines. A surveyor was positioned at the north-eastern back side of the leisure centre at VP1 giving good views of the barns from an north-eastern aspect (figure 2 at appendix 3). A surveyor was positioned at VP2 at the south-western aspect of the leisure centre giving good views of the south-western side of the building. Completing one dusk emergence survey and one dawn re-entry survey at each side of the leisure centre using two surveyors to give the best views of the building and view the most likely bat exit/entry points if there was a potential roost within the leisure centre.

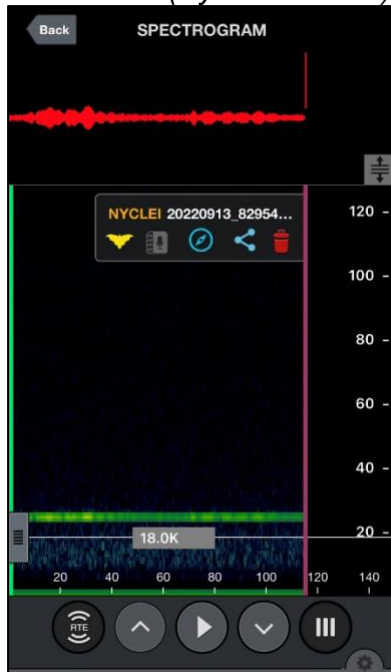
Leislars Bat (*Nyctalus leisleri*) Sonogram

- 1.18 Emergence survey on the 13/09/22 recorded a single leisler foraging within the site boundaries. No bats were recorded emerging from the leisure centre.
- 1.19 No species of bats were recorded during the re-entry survey on the 28/08/22.
